Four-Point Insurance Inspection Report

May 22, 2026

400 Underwriting Palm Drive Four Point , Orlando, FL 32801

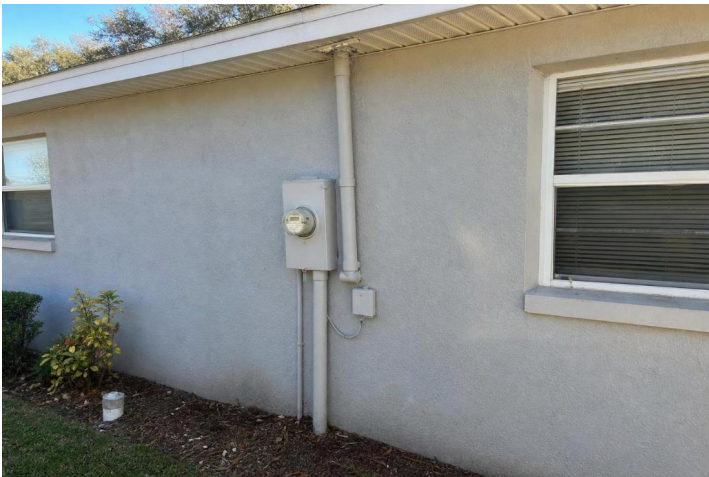
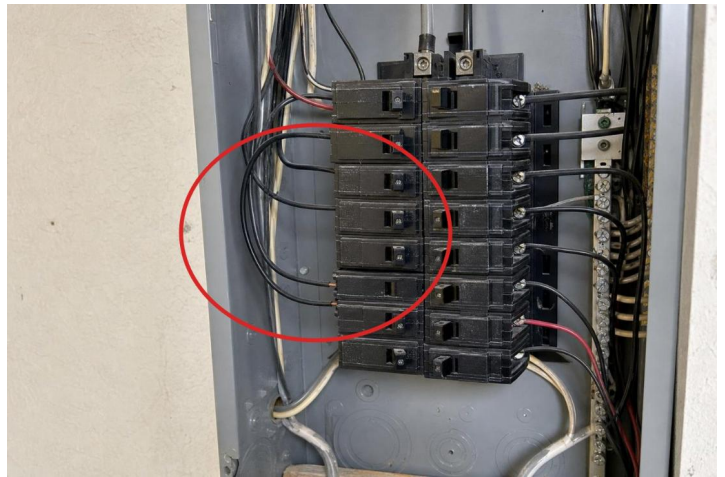
Electrical system photos - Electrical system photos

Electrical System - Double-tapped circuit breakers were identified in the panel. Most breakers are rated for only a single conductor; landing two conductors under one breaker terminal can cause loose connections, arcing, and fire risk.

The service is provided by two circuit-breaker panels. The main panel is a Square D QO rated at 150 amps; a second panel rated at 60 amps is also present. Brand and model of the second panel were not determined. Age and last-update year were not determined for either panel. Both panels are reported to have amperage sufficient for current usage. Wiring is copper throughout, installed in NM, BX, or conduit — no cloth wiring, active knob-and-tube, or branch-circuit aluminum wiring was identified, and no COPALUM or AlumiConn repairs are present. Among the surveyed hazard conditions — blowing fuses, exposed wiring, tripping breakers, empty sockets, unsafe wiring, improper breaker sizing, loose wiring, scorching, improper grounding, corrosion, and over-fusing — none were observed. Double-taps were, however, identified in the panel. The overall electrical system condition is rated unsatisfactory.

Engage a licensed electrician to evaluate all double-tapped breakers. Remediation typically involves adding a tandem (duplex) breaker listed for the panel, or installing a sub-feed to accommodate the additional circuits properly.

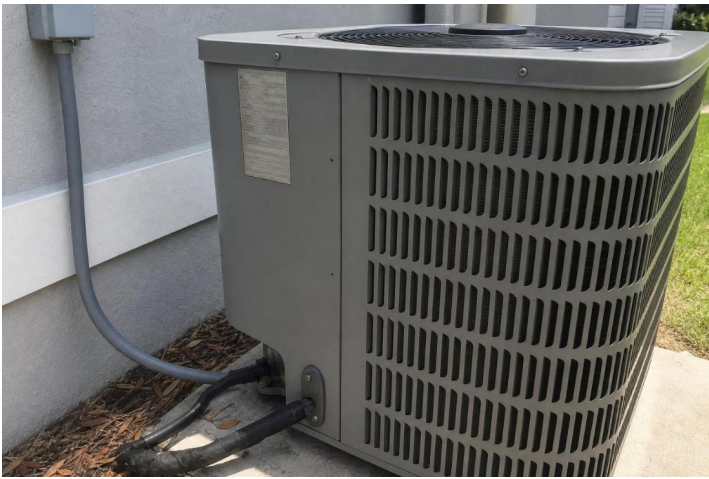
HVAC system photos - HVAC system photos

The property is served by central air conditioning and central heat. The system carries a 2019 manufacture year and was last updated in 2019. The most recent servicing on record coincides with the inspection date. All heating, ventilation, and air conditioning systems are reported to be in good working order. No blockage, leakage, or water damage was observed at the air handler, condensate line, or drain pan. No wood-burning stove or gas fireplace with non-professional installation was identified, and no portable or fixed space heater is used as a primary heat source.

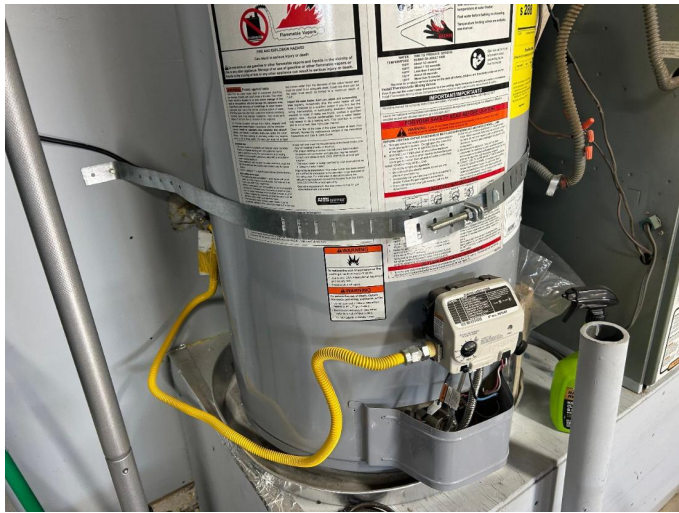
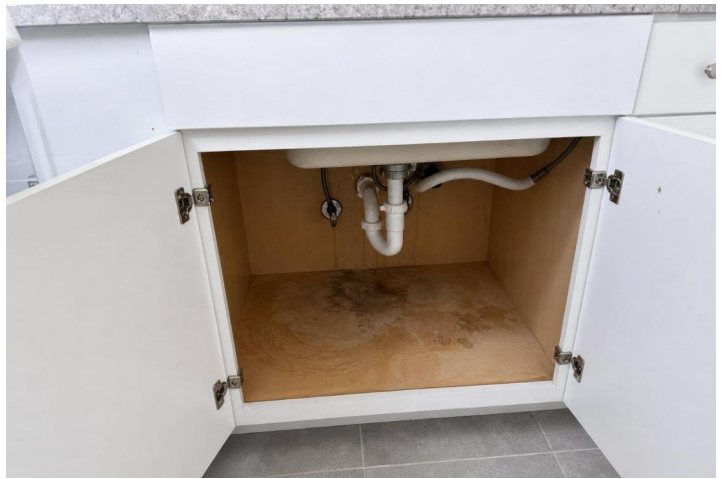
Plumbing system photos - Plumbing system photos

Plumbing System - Past water staining was observed below the kitchen sink cabinet, indicating a prior leak. Sink condition is rated unsatisfactory. No active dripping was present at the time of inspection.

Unsatisfactory comments / details
Past staining was observed below the kitchen sink cabinet. No active dripping was observed at the time of inspection.

Have a licensed plumber inspect the drain, supply connections, and cabinet floor beneath the kitchen sink to identify the source of the prior leak, confirm no ongoing seepage exists, and make any necessary repairs. Address any resulting moisture damage to cabinetry or subfloor.

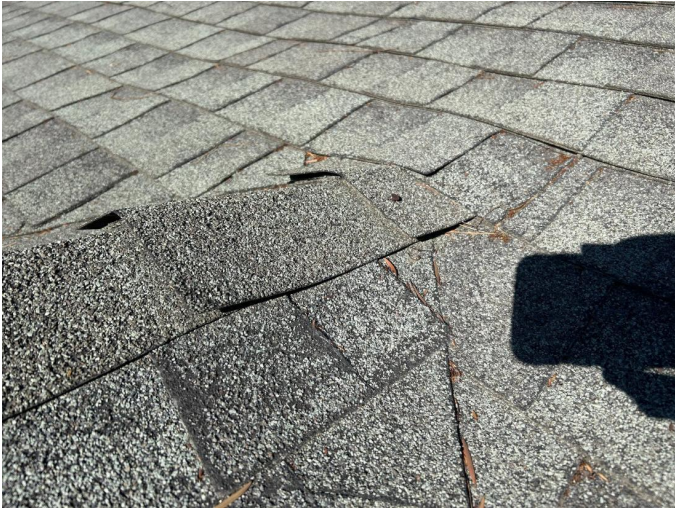
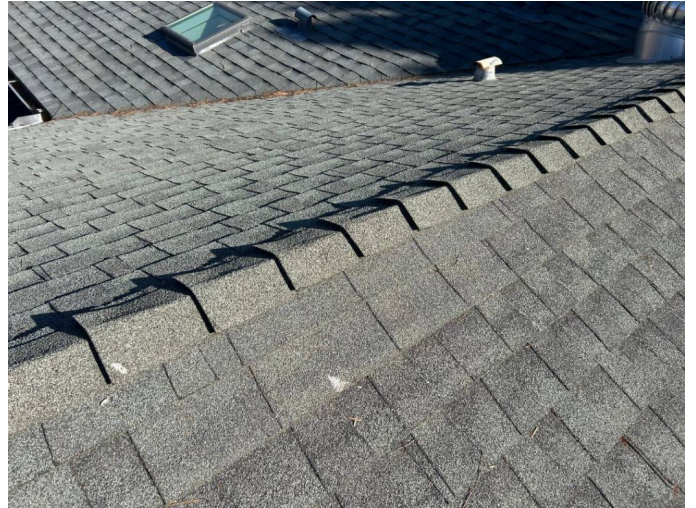
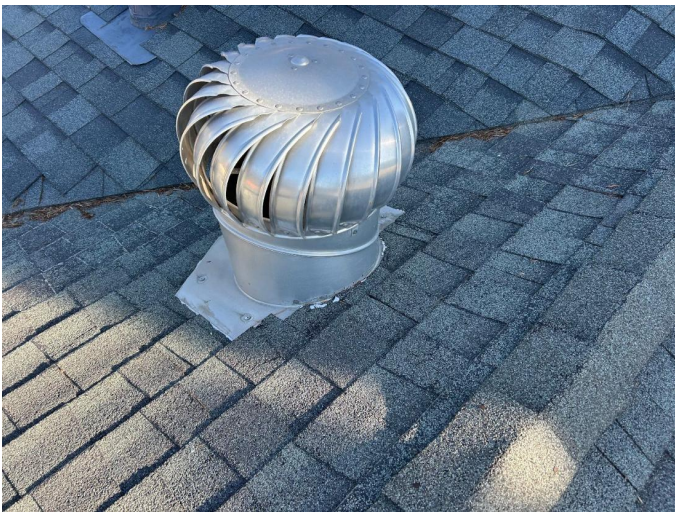
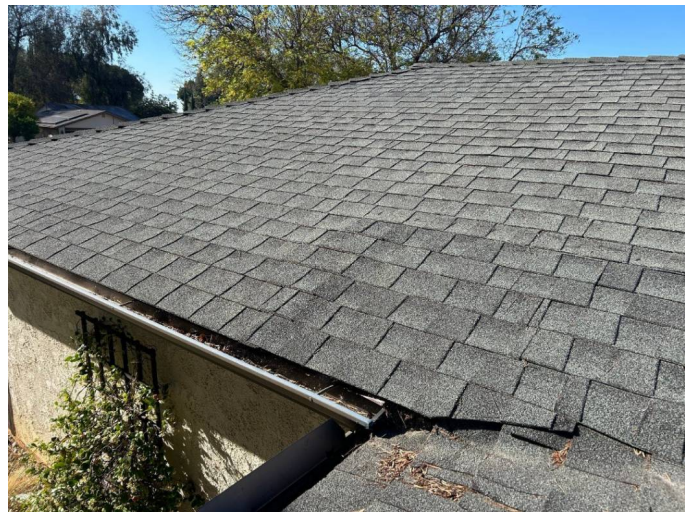
Roof photos - Roof photos

Roof - Excessive granule loss was observed on the asphalt shingle roof surface.

The predominant roof covering is asphalt shingle, approximately 6 years old with an estimated 8 years of remaining useful life. The roof was fully replaced (100%) at the time of the last update, with a roofing permit on file dated at the time of inspection. Overall condition is rated satisfactory. The inspector noted excessive granule loss as the only visible damage or deterioration item. No cracking, cupping or curling, exposed asphalt or felt, missing or loose tabs, soft spots in decking, or visible hail damage were observed. No visible signs of leaks were identified at the roof surface, attic or underside of decking, interior ceilings, or any secondary roof area.

Monitor granule loss progression at each annual inspection. Have a licensed roofing contractor evaluate the extent and determine whether localized repair or accelerated replacement planning is warranted, particularly given the estimated 8 years of remaining useful life.

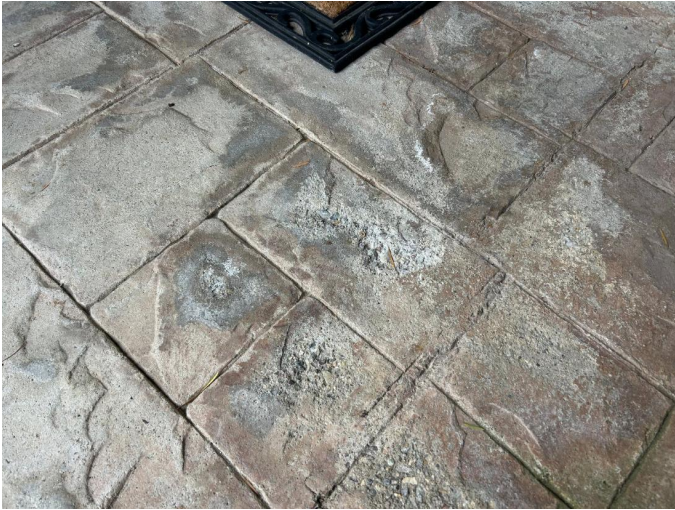
Additional photos - Additional photos

The inspector noted efflorescence on the foundation. Efflorescence is a mineral salt deposit left by migrating moisture and can be an early indicator of ongoing water intrusion or hydrostatic pressure against the foundation wall.

efflorescence was noticed on the foundation.

Have a qualified contractor or structural engineer evaluate the foundation for active water intrusion, deterioration, or hydrostatic pressure concerns. Address any identified drainage, waterproofing, or grading deficiencies contributing to moisture migration.
