## FOUR-POINT INSURANCE INSPECTION REPORT

### 400 Underwriting Palm Drive

Orlando, FL 32801

Inspected on Jul 10, 2026

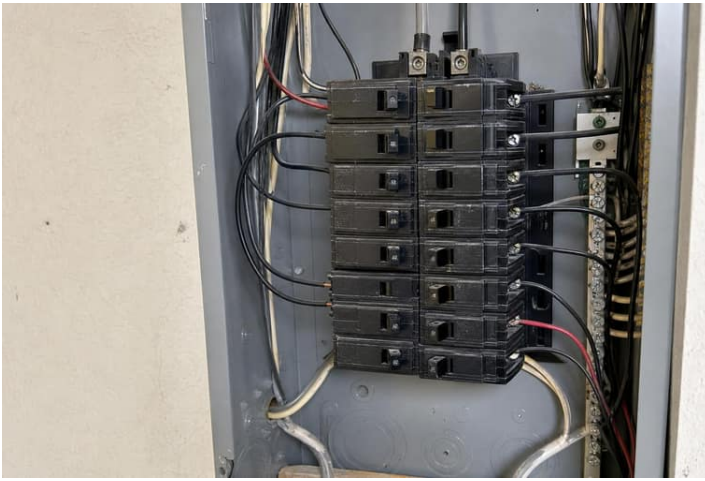
Electrical System - One or more breakers in the 150-amp Square D QO main panel were observed with two conductors landed on a single breaker terminal not rated for that configuration, creating a potential overload and loose-connection hazard.

Electrical system photos - Double-tapped breaker observed in the main panel.

Have a licensed electrician evaluate and correct all double-tapped breakers by installing appropriately rated tandem breakers or adding a sub-panel circuit as needed.

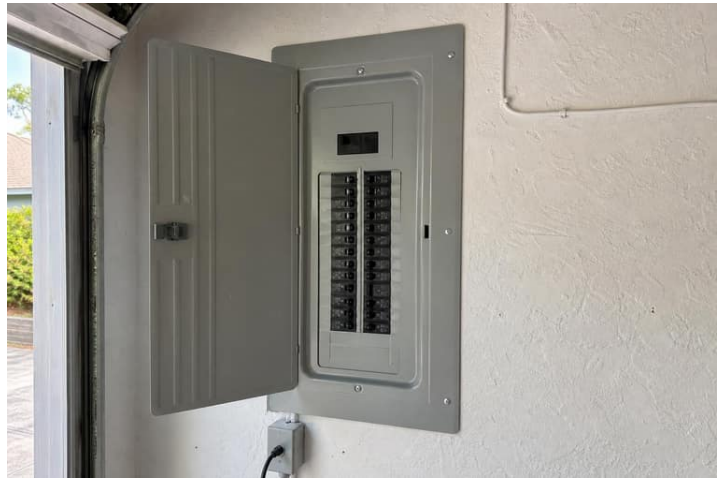
Electrical system photos - Main panel overview; 150-amp circuit breaker panel.

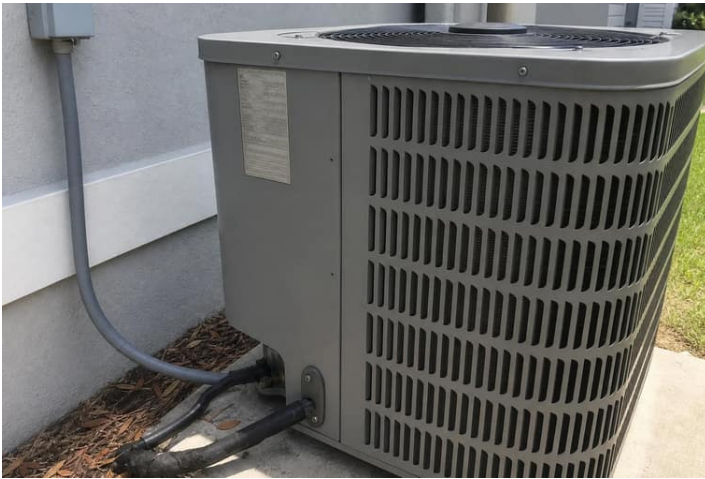
HVAC system photos - HVAC equipment and data plate area; 2019 manufacture year.

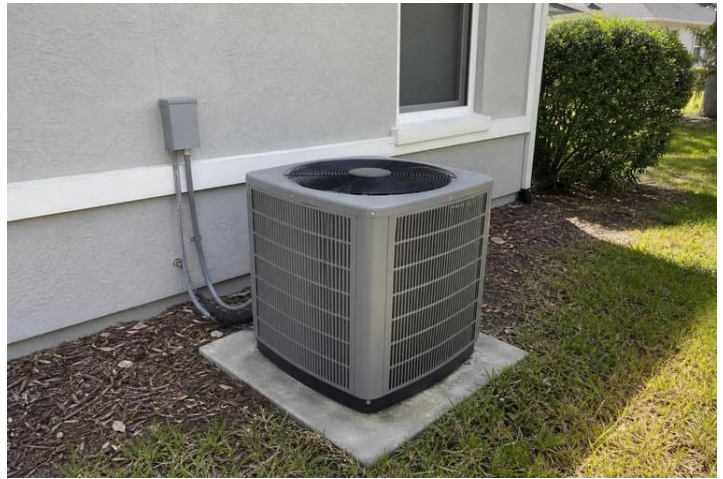
HVAC system photos - Exterior condenser in serviceable condition.

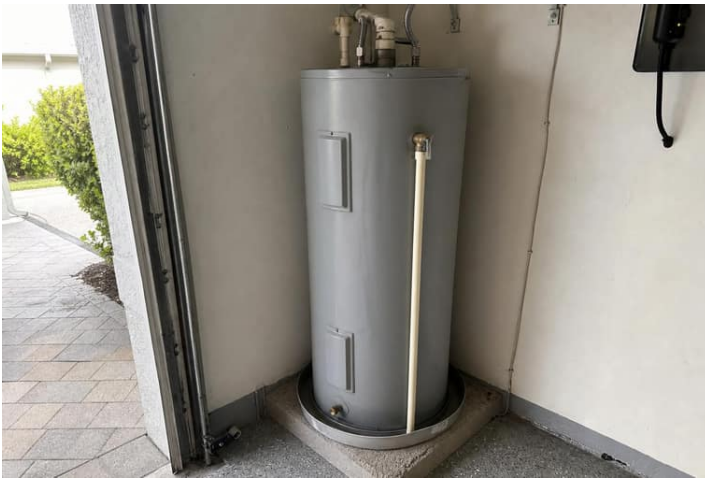
Plumbing system photos - Garage water heater with TPR valve present; satisfactory condition.

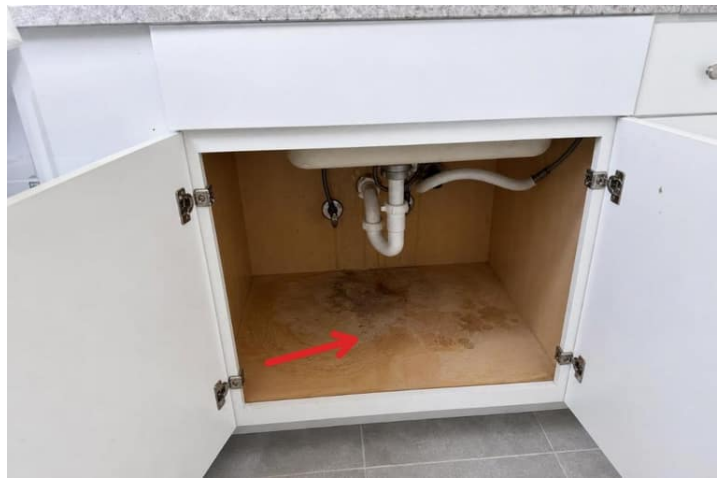
Plumbing system photos

Plumbing System - Past staining was observed below the kitchen sink cabinet, indicating a prior leak event. No active dripping was present at the time of inspection.

Past staining was observed below the kitchen sink cabinet. No active dripping was observed at the time of inspection.

Have a licensed plumber evaluate the sink drain, supply connections, and surrounding cabinetry for the source of the prior leak and make any necessary repairs. Remediate any residual moisture or microbial concern as appropriate.

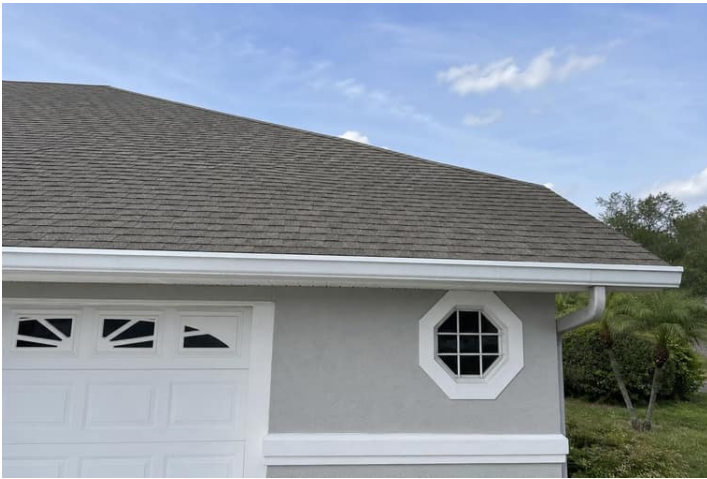
Roof photos - Front roof slope; shingles in satisfactory condition.

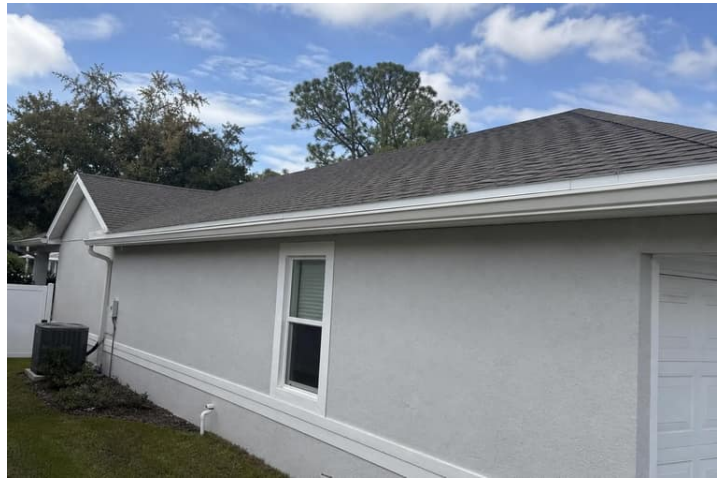
Roof photos - Left side roof slope; shingles in satisfactory condition.

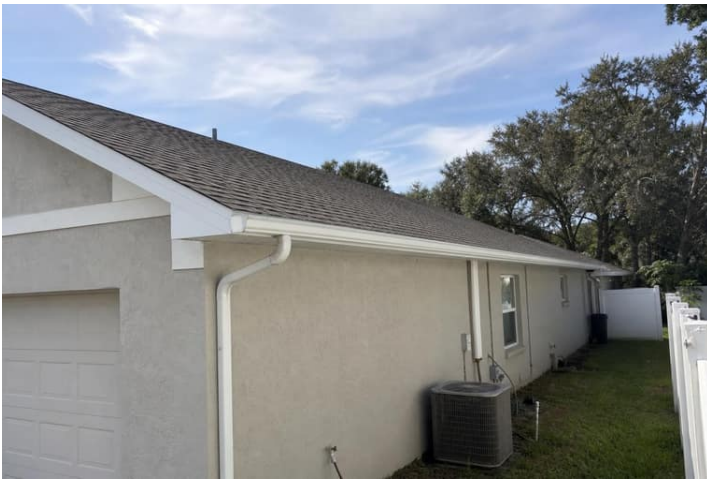
Roof photos - Right side roof slope; shingles in satisfactory condition.

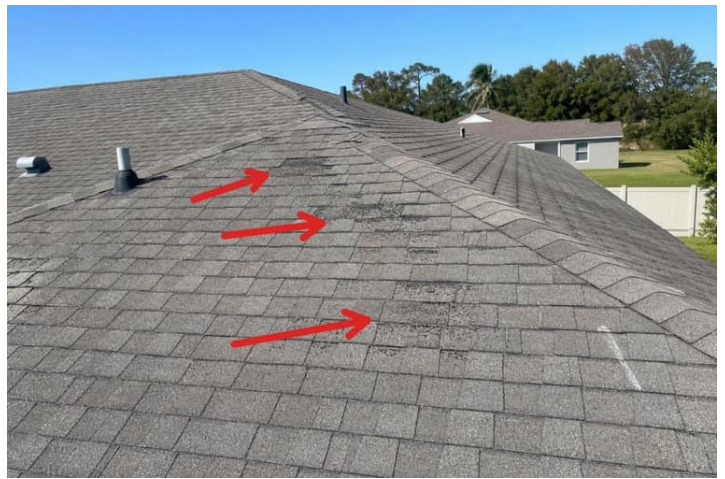
Roof photos

Roof - Granule loss was observed on the rear slope of the 6-year-old asphalt shingle roof, contributing to a reduced remaining useful life estimate of approximately 8 years.

Have a licensed roofing contractor evaluate the affected area and perform repairs or targeted shingle replacement as warranted to extend serviceable life.

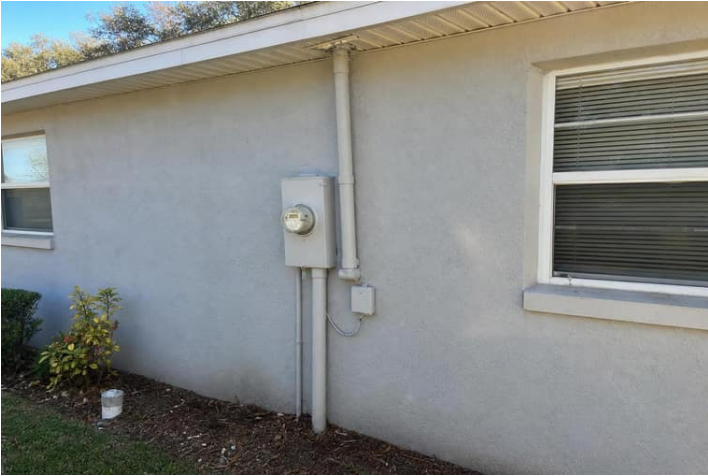
Additional photos - Additional context photo for noted minor deficiencies.
