## Summit Home Inspection

## MOLD VISUAL MOISTURE INSPECTION REPORT

## 122 Fort Bellingham Road

Inspected on Jul 10, 2026

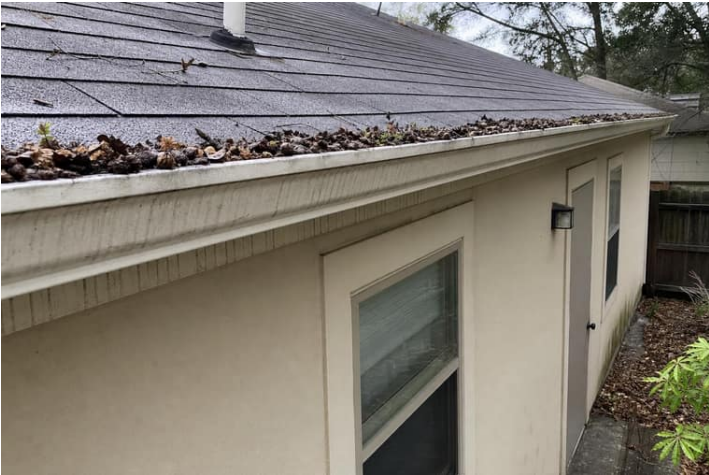
Roof - A debris-filled rear gutter and staining below the eave were observed at the laundry-side wall, indicating a drainage concern and evidence of moisture intrusion.

Notes: Debris-filled rear gutter and staining below the eave were observed at the laundry-side wall.

Roof 2.1a - Roof drainage and covering viewed for moisture intrusion concerns.

Clean the rear gutter and monitor the eave area for continued moisture intrusion; repair or reseal as needed to prevent further water entry.

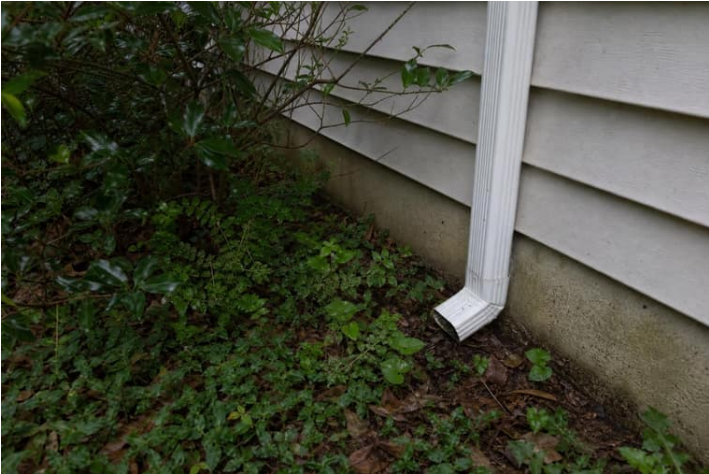
Exterior and Grounds - The rear downspout discharged near the foundation, and dense vegetation was in contact with the wall cladding, both moisture-conducive conditions.

| <b>Exterior grading and drainage around building perimeter</b><br><br>Status: inspected<br>Defects: Downspout discharge near foundation; Vegetation contact; Moisture-conducive condition<br>Notes: Rear downspout discharged near the foundation and dense vegetation contacted the wall cladding. | CORRECTION NEEDED |

Exterior and Grounds 3.2a - Exterior grading and drainage around the inspected building perimeter.

Extend the downspout discharge away from the foundation and trim back vegetation from the wall cladding to reduce moisture exposure.

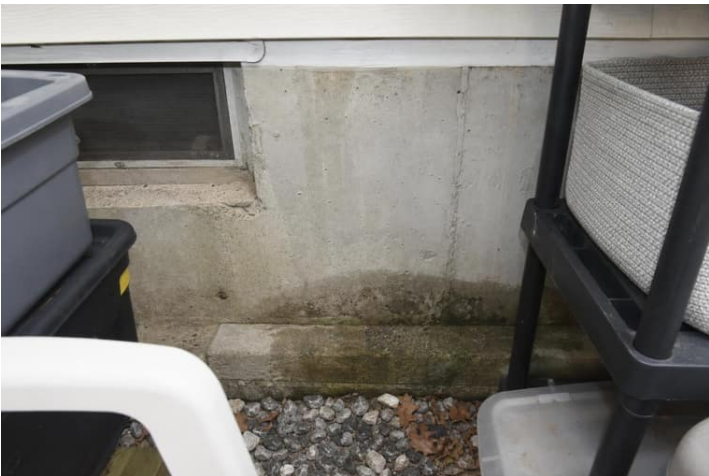
Foundation and Crawlspace 4.1a - Foundation area checked for visible moisture indicators.

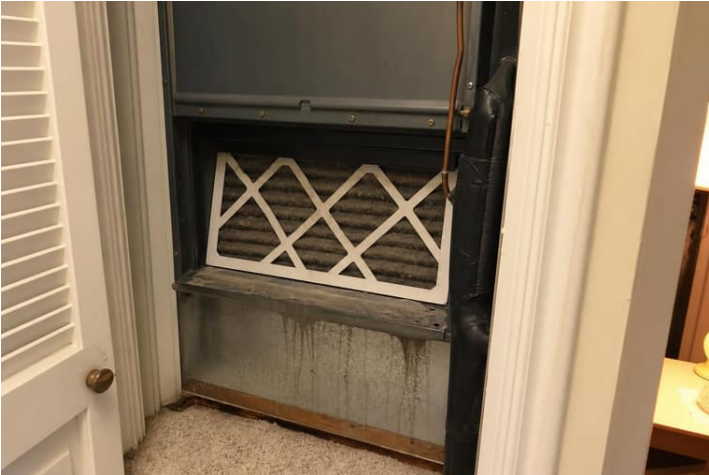
HVAC and Ventilation - The air handler filter was dirty, and moisture staining was visible at the adjacent return plenum.

Notes: Air handler filter was dirty and moisture staining was visible at the adjacent return plenum.

HVAC and Ventilation 5.1a - Air handler and filter area reviewed for moisture and growth indicators.

Replace the air handler filter and evaluate the return plenum for the source of the moisture staining; repair as needed.

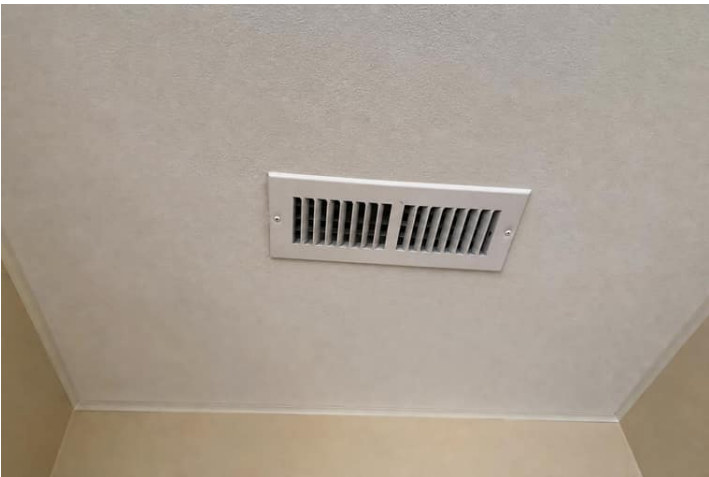
HVAC and Ventilation 5.3a - Representative supply register and surrounding finish condition.

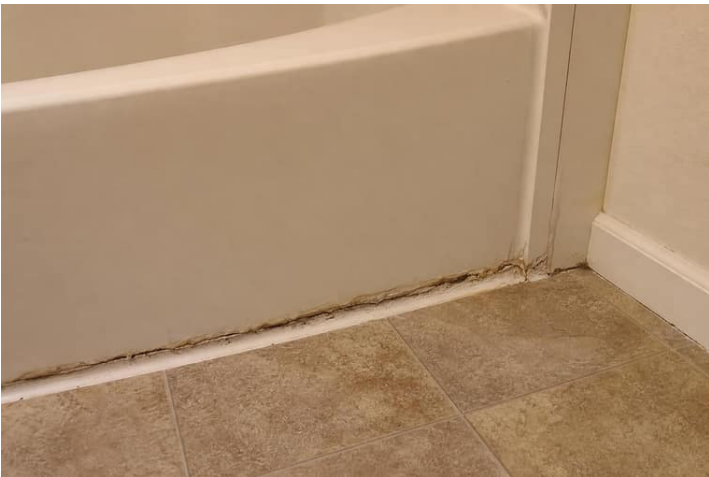
Plumbing - Deteriorated caulk was present at the tub surround, with water damage nearby and elevated moisture readings at the adjacent base trim.

| Notes: Guest bathroom tub surround had deteriorated caulk and elevated moisture readings at the adjacent base trim. | |

Plumbing 6.2a - Bathroom fixture and nearby finish checked for moisture indicators.

Re-caulk the tub surround and evaluate/repair the adjacent base trim affected by moisture intrusion.

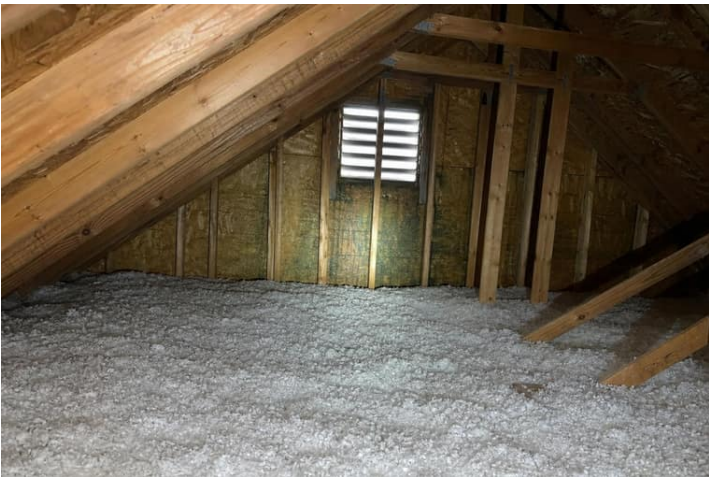
Attic, Ventilation, and Insulation 7.1a - Attic insulation and ventilation reviewed for moisture-related conditions.

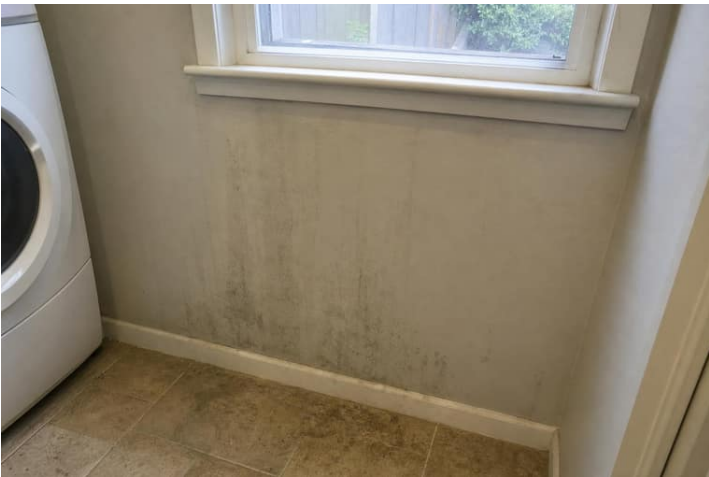
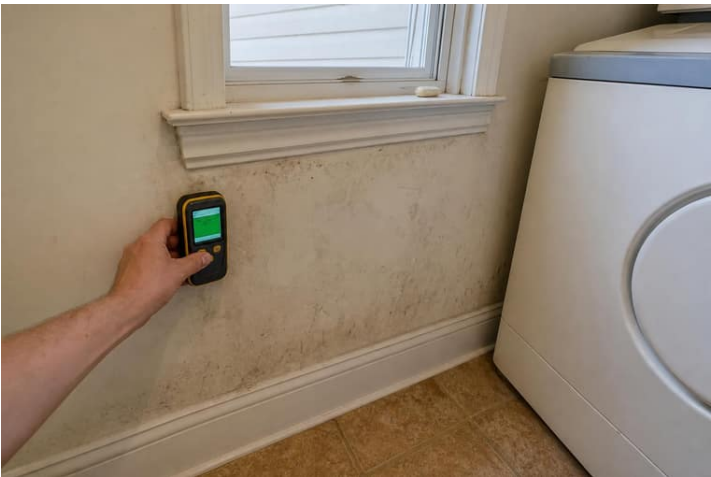
Interior - The laundry wall below the rear window showed water staining, a musty odor, and elevated moisture meter readings.

Notes: Laundry wall below the rear window had staining, a musty odor, and elevated moisture meter readings.

Interior 8.1a - Interior wall and ceiling area checked for staining or moisture indicators.

Interior 8.1b - Moisture meter location at the stained laundry wall below the rear window.

Investigate and correct the source of moisture at the laundry wall below the rear window, and repair affected finishes.

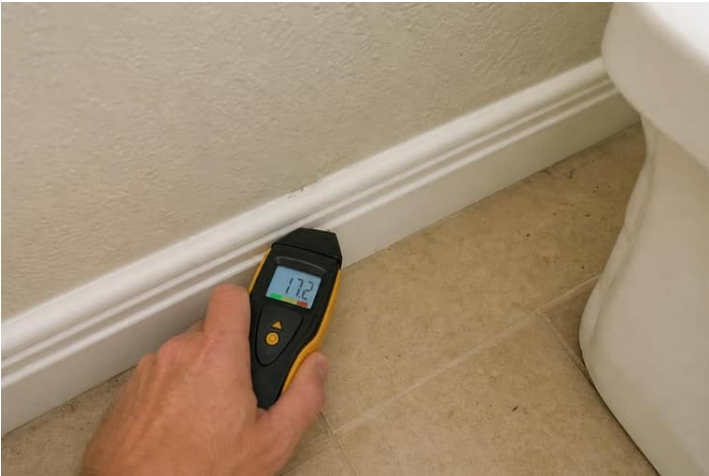
Moisture, Humidity, and Temperature - Elevated moisture readings were recorded at the laundry wall and guest bathroom base trim, consistent with the moisture concerns noted in the laundry and bathroom areas.

Status: inspected  
Defects: Elevated moisture reading; Moisture detected  
Notes: Elevated moisture readings were recorded at the laundry wall and guest bathroom base trim.

Moisture, Humidity, and Temperature 9.1a - Representative moisture meter location for area of concern.

Address the underlying moisture sources at the laundry wall and guest bathroom base trim and re-check readings after repairs.
