Pool / Spa Inspection Report

May 30, 2026

888 Bluewater Bend V3 QA 20260530-010442-252, Austin, TX 78704

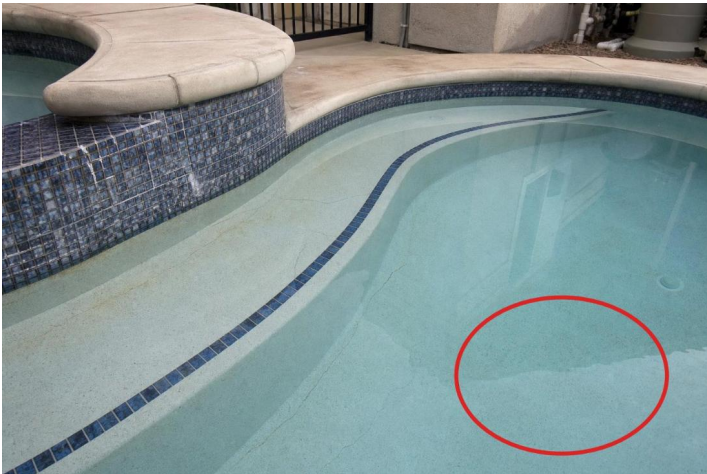
Pool / Spa Structure 1.1a - Pool/spa shell and visible surfaces

Pool / Spa Structure - Hairline cracking and staining were observed at the shallow-end step and at the waterline tile transition.

Notes: Hairline cracking and staining were observed at the shallow-end step and waterline tile transition.

Have a licensed pool surface or tile contractor evaluate the cracking and staining. Hairline cracks at step and tile transition areas can allow water infiltration and may worsen over time if left unaddressed.

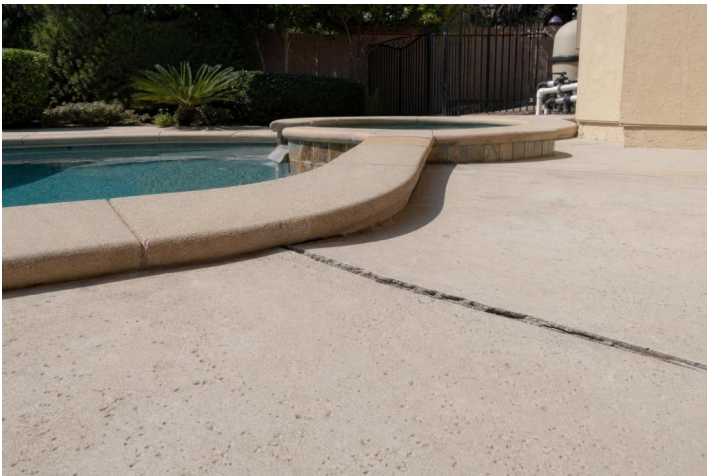
Deck and Access 2.1a - Decking and walking surface condition

Deck and Access - A raised, cracked deck edge near the north coping was observed, creating a trip hazard.

Notes: Raised cracked deck edge near the north coping created a trip hazard.

Have a qualified contractor grind, patch, or replace the raised cracked deck section to eliminate the trip hazard. This area should be addressed promptly given the safety risk to pool users.

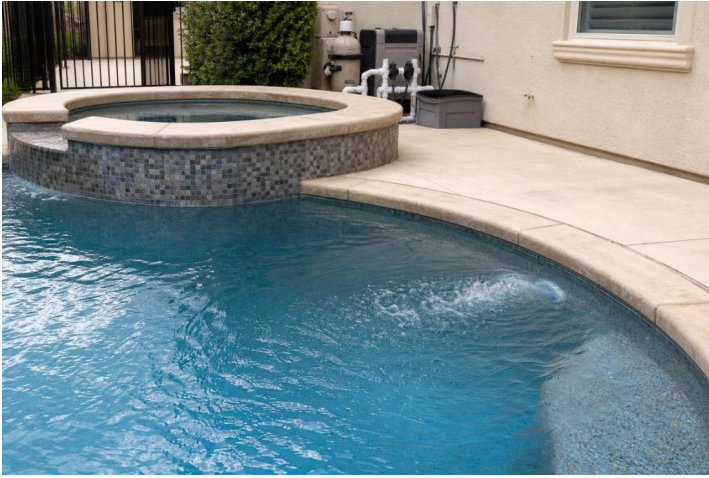
Water Flow and Circulation 3.1a - Basic water flow and circulation

Notes: QA seed: inspected with no correction needed.

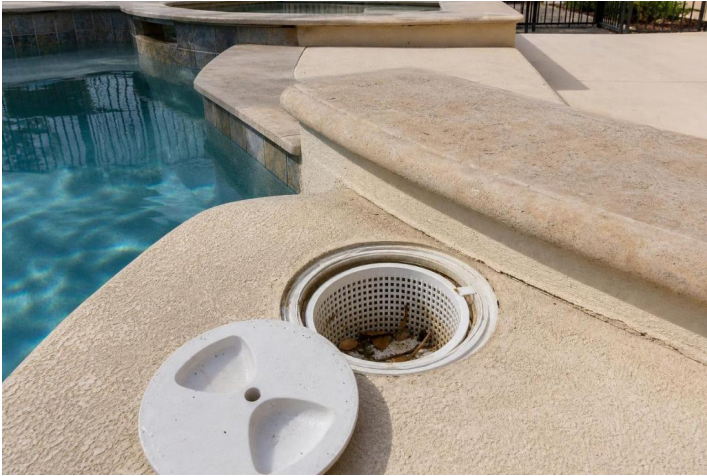
Drains, Covers, and Returns 4.2a - Skimmer weirs, baskets, and deck covers

Notes: QA seed: inspected with no correction needed.

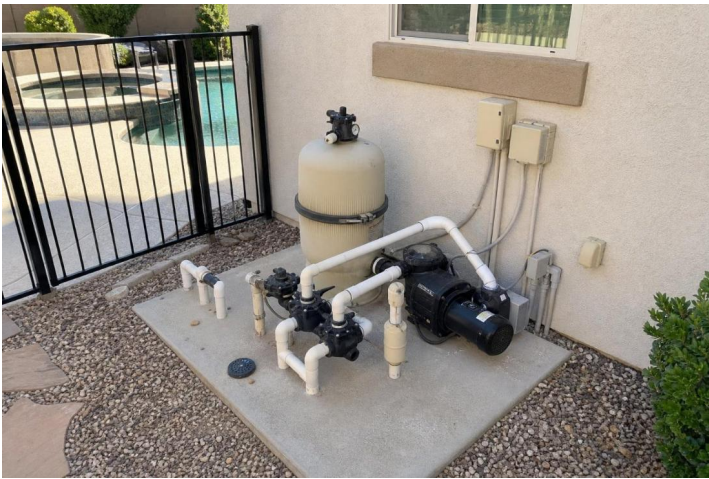
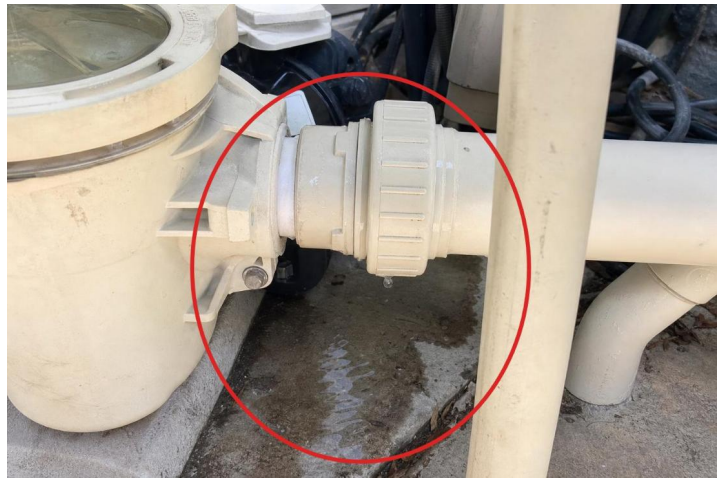
Pump, Filtration, and Plumbing 6.1a - Pump operation and visible condition

Pump, Filtration, and Plumbing - An active drip was observed at the pump union, and the pump produced louder-than-typical bearing noise during operation.

Notes: Pump operated with a minor active drip at the union and louder-than-typical bearing noise.

Have a licensed pool equipment technician inspect and repair the pump union leak and evaluate the pump motor bearings. An active water leak at a union can worsen and cause equipment damage; abnormal bearing noise may indicate the motor is approaching end of service life.

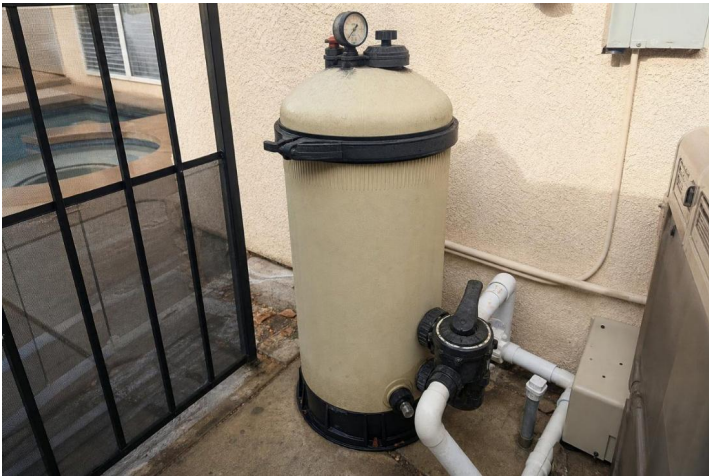
Pump, Filtration, and Plumbing 6.2a - Filter tank and filter components

Notes: QA seed: inspected with no correction needed.

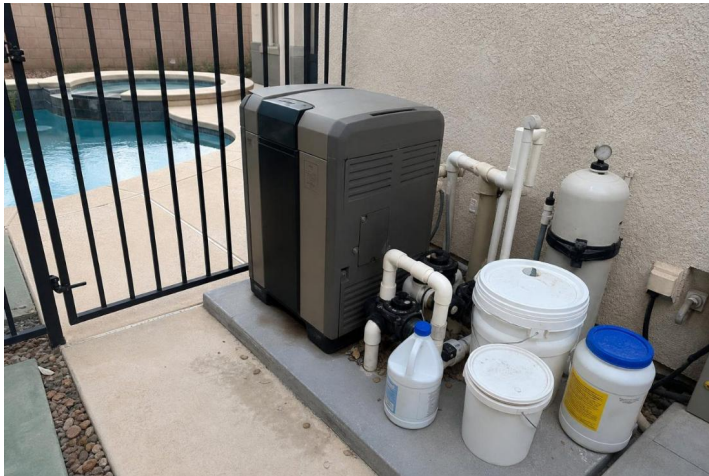
Heater and Heating Equipment 7.1a - Heater visible condition and installation

Heater visible condition and installation Status: inspected Notes: QA seed: inspected with no correction needed.	PASS
---	---

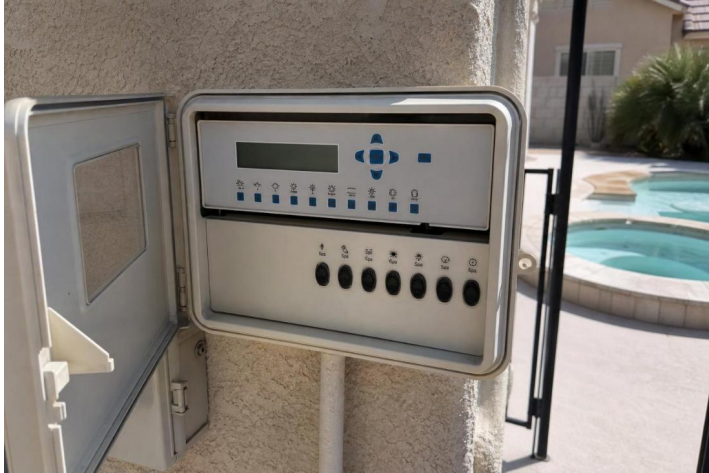
Electrical, Lighting, and Bonding 8.3a - Lights and controls observed

Electrical, Lighting, and Bonding - The spa light did not respond when activated at the automation panel during the inspection.

Notes: Spa light did not respond at the automation panel during the check.

Have a licensed pool electrician or automation technician inspect and repair the spa light circuit. Non-functional underwater lighting should be evaluated to confirm the fixture, wiring, and control connection are intact and safe.

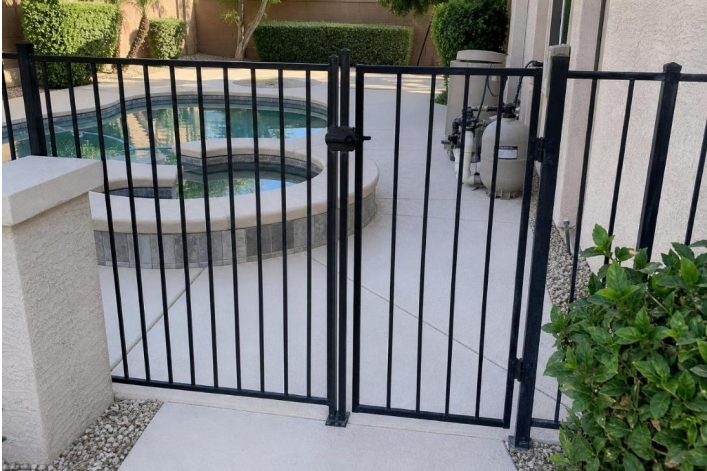
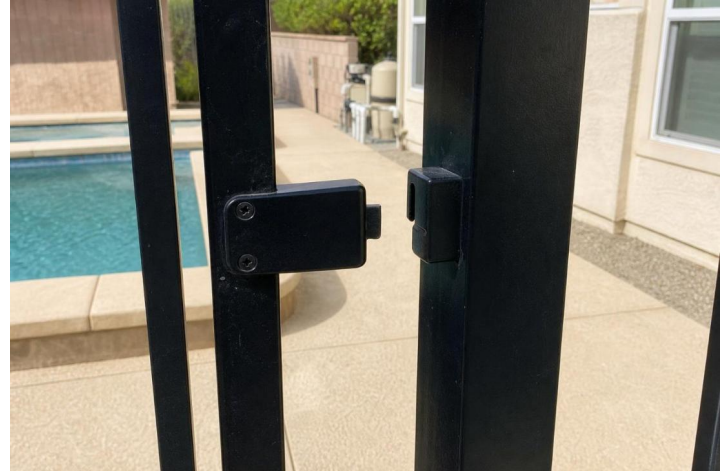
Safety Barriers and Devices 9.2a - Gate self-closing/latching

Safety Barriers and Devices - The west-side pool gate did not consistently self-close and latch during the inspection.

Notes: West side pool gate did not consistently self-close and latch.

Repair or replace the gate self-closing mechanism and latch hardware immediately. A pool gate that does not reliably self-close and latch poses a serious drowning risk, particularly where children are present. This item should be corrected before the pool is used.

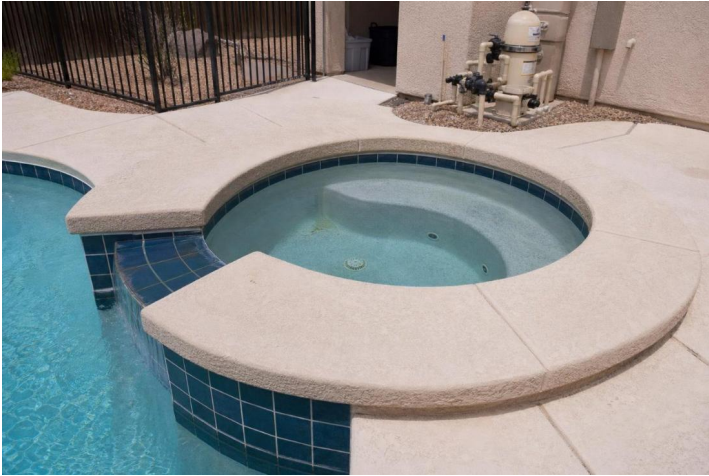
Spa Systems and Limitations 10.1a - Spa visible condition and operation

Notes: QA seed: inspected with no correction needed.
