# Cornerstone Home & Environmental RADON MITIGATION SYSTEM INSPECTION REPORT

## 44112 Oakridge Dr

Charlotte, NC 28216  
Inspected on Jul 10, 2026

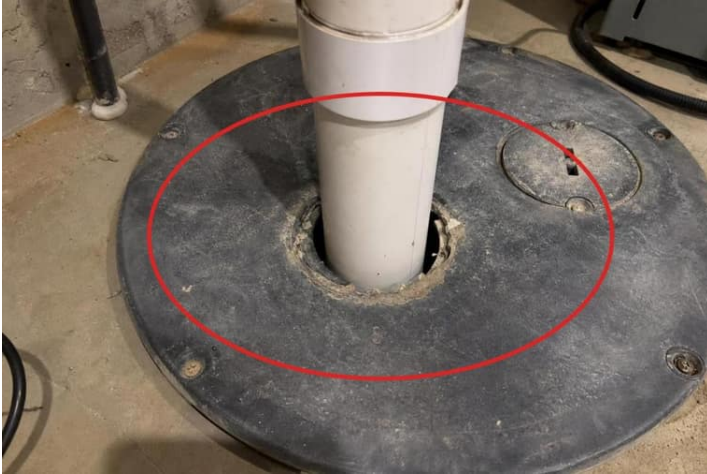
Drain-Tile, Sump, And Suction Points - The sump cover was present, but the pipe penetration seal through the cover was incomplete, and the cover itself was not airtight.

Defects: Cover not airtight; Penetration not sealed

Notes: The sump cover was present, but the pipe penetration seal was incomplete.

Drain-Tile, Sump, And Suction Points 2.1a - Sump pit cover and suction point seal

Recommend sealing the pipe penetration and cover to an airtight condition; evaluation and correction by a qualified radon mitigation contractor is advised.

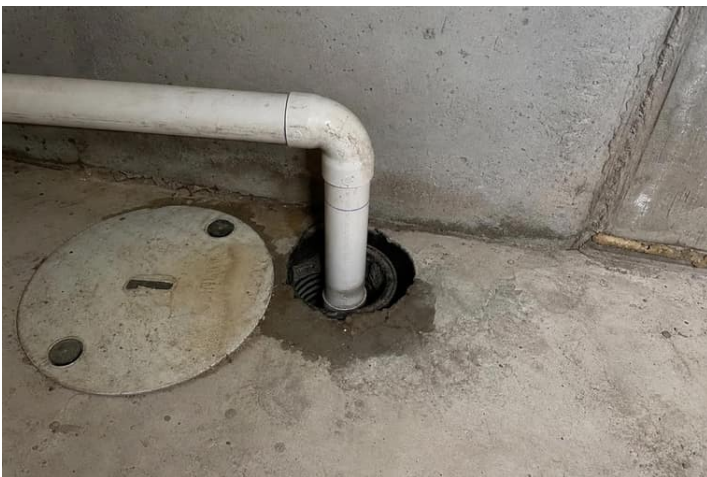
Drain-Tile, Sump, And Suction Points - A one-way flow valve was not observed at the visible drain discharge, and the drain control configuration could not be fully determined.

Defects: One-way valve not observed; Drain control not determined

Notes: A one-way flow valve was not observed at the visible drain discharge.

Drain-Tile, Sump, And Suction Points 2.2a - Drain control location where a one-way valve was not observed.

Recommend further evaluation by a qualified radon mitigation contractor to confirm the presence and function of appropriate drain flow controls.

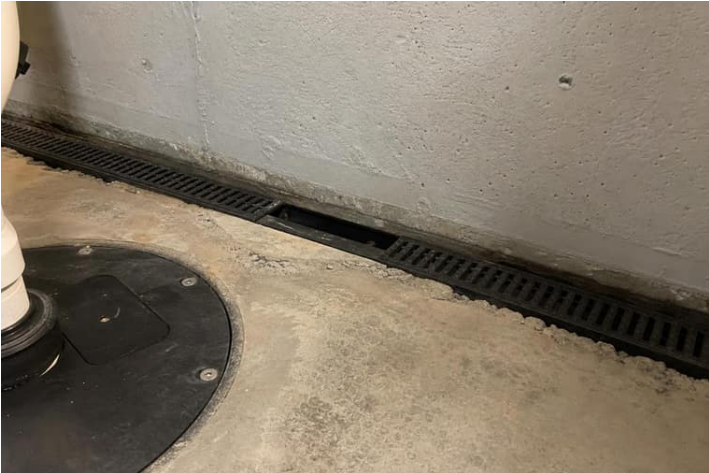
Drain-Tile, Sump, And Suction Points - The perimeter drain detail was not fully sealed at the sump cover, and the trapped drain configuration could not be verified.

Status: inspected  
Defects: Unsealed perimeter/channel/French drain; Sump drain trap concern  
Notes: Perimeter drain detail was not fully sealed at the sump cover and trapped drain configuration could not be verified.

Drain-Tile, Sump, And Suction Points 2.4a - Unsealed perimeter drain detail at the sump area.

Recommend evaluation and sealing of the perimeter drain connection at the sump by a qualified radon mitigation contractor.

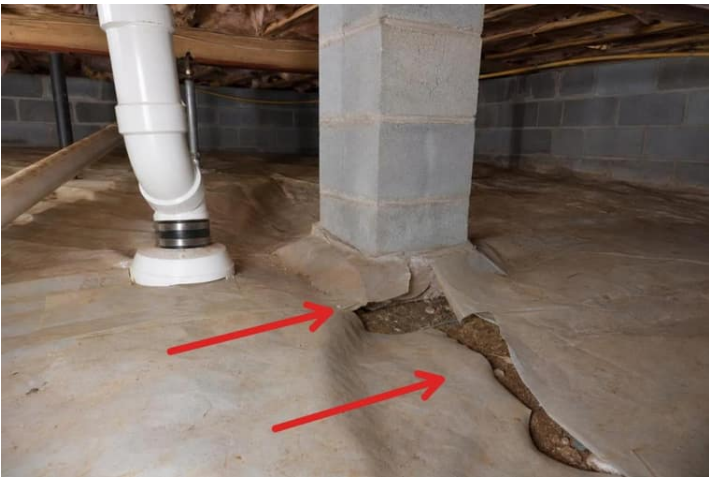
Crawlspace And Membrane Systems - The crawlspace vapor retarder had loose, unsealed edges and a small tear near one support pier.

Status: inspected  
Defects: Edges not sealed; Membrane damaged  
Notes: The crawlspace vapor retarder had loose edges and a small tear near one pier.

Crawlspace And Membrane Systems 3.1a - Vapor retarder seams, edges, and penetrations

Recommend repairing the tear and resealing the membrane edges to restore an intact vapor retarder.

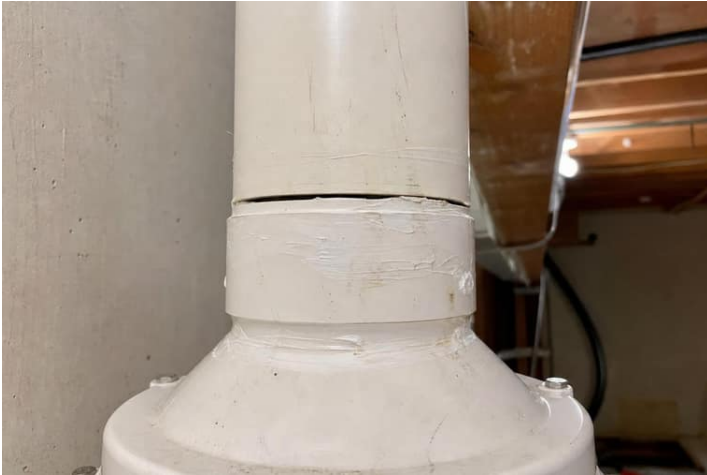
Vent Piping, Fittings, And Supports - An accessible pipe joint near the fan had visible sealant gaps, presenting a potential air leakage concern.

Defects: Joint not sealed; Air leakage concern

Notes: One accessible pipe joint near the fan had visible sealant gaps.

Vent Piping, Fittings, And Supports 4.2a - Accessible pipe joint with visible sealant gap.

Recommend resealing the pipe joint near the fan to eliminate the visible gap.

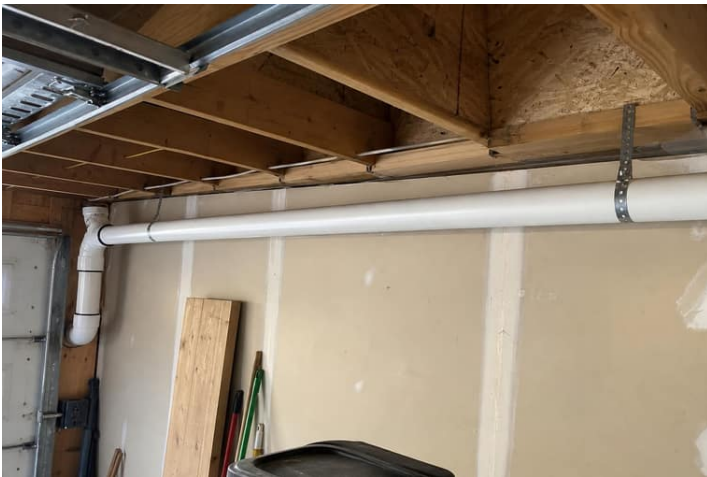
Vent Piping, Fittings, And Supports - A horizontal pipe run in the garage had wide support spacing, an inadequate support condition.

Defects: Inadequate support; Support spacing concern

Notes: A horizontal run in the garage had wide support spacing.

Vent Piping, Fittings, And Supports 4.3a - Horizontal piping support spacing concern.

Recommend adding additional pipe supports at appropriate intervals along the horizontal garage run.

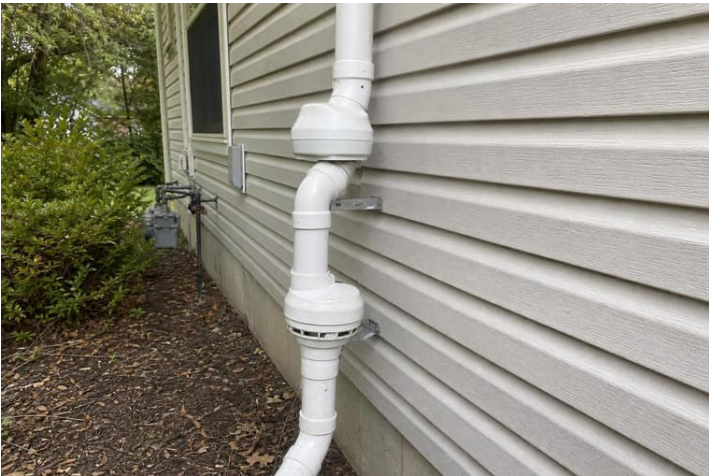
Vent Piping, Fittings, And Supports - An exterior pipe section was exposed to physical damage, and the Schedule 40 material rating could not be verified from visible markings.

| <b>Radon mitigation material requirements</b><br><br>Status: inspected<br>Defects: Schedule 40 material concern<br>Notes: Exterior pipe section was exposed to physical damage and the Schedule 40 rating could not be verified from visible markings. | CORRECTION NEEDED |

Vent Piping, Fittings, And Supports 4.6a - Exterior piping material and visible marking condition.

Recommend protecting the exposed pipe section from physical damage and having a qualified radon mitigation contractor confirm the pipe material rating.

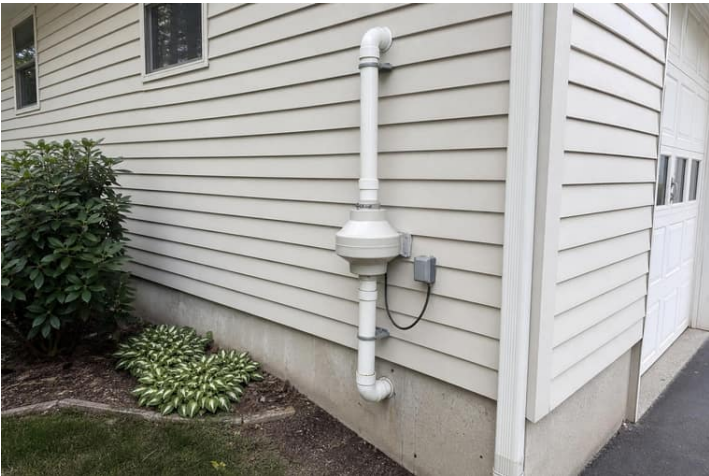
Status: inspected  
Notes: The radon fan was mounted at the exterior wall and appeared secured.

Radon Fan And Discharge 5.1a - Exterior radon fan mounting and visible installation.

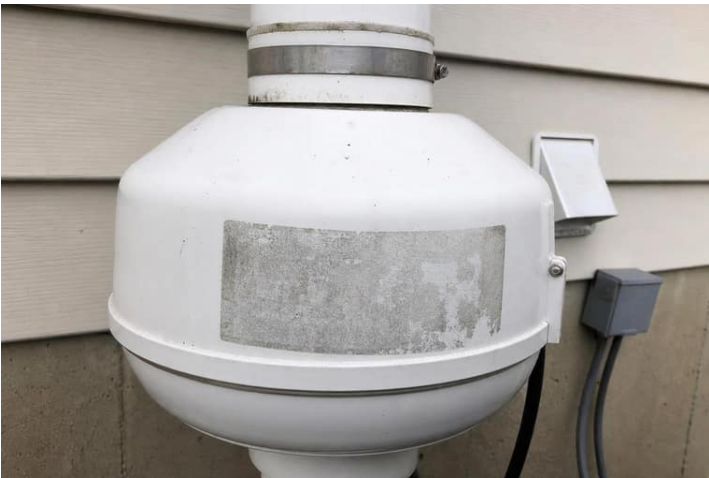
Radon Fan And Discharge - The fan housing label was weathered and not fully legible, and the housing showed damage; the weather rating could not be verified.

Status: inspected  
Defects: Weather rating not verified; Damaged housing  
Notes: The fan housing label was weathered and not fully legible.

Radon Fan And Discharge 5.2a - Weathered fan label where rating was not verified.

Recommend evaluation of the fan housing and label by a qualified radon mitigation contractor to confirm weather rating and condition.

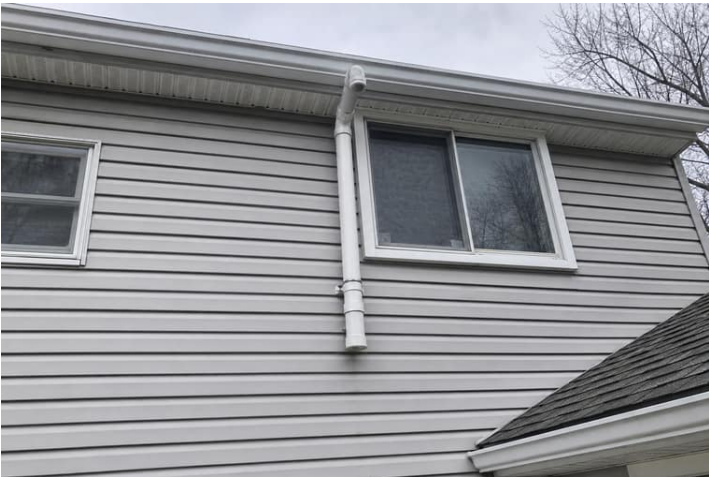
Radon Fan And Discharge - The exhaust termination appeared near an upper-level window; exact clearance from the opening was not measured or determined.

Status: inspected  
Defects: Discharge near opening; Clearance not determined  
Notes: The exhaust termination appeared near an upper-level window; exact clearance was not measured.

Radon Fan And Discharge 5.3a - Discharge termination near an upper-level window.

Recommend a qualified radon mitigation contractor verify discharge clearance from the nearby window opening meets accepted installation guidance.
