# TEXAS REI PROPERTY INSPECTION REPORT

## 210 TREC Oak Hollow Drive

Inspected on Jul 10, 2026

# PROPERTY INSPECTION REPORT FORM

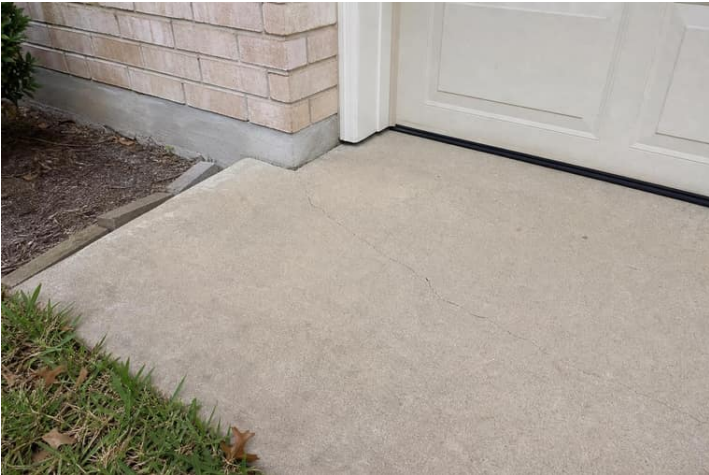
Visible portions of the foundation were inspected. Minor hairline cracking was observed without significant displacement.

Minor hairline foundation cracking without significant displacement.

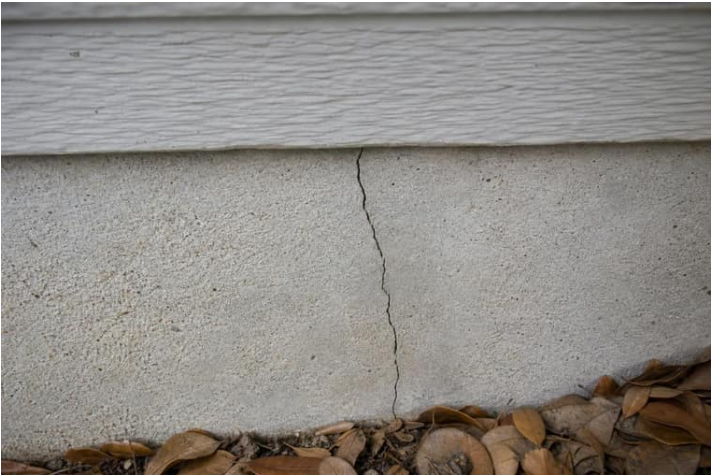
Close detail of the hairline slab crack showing minimal surface separation.

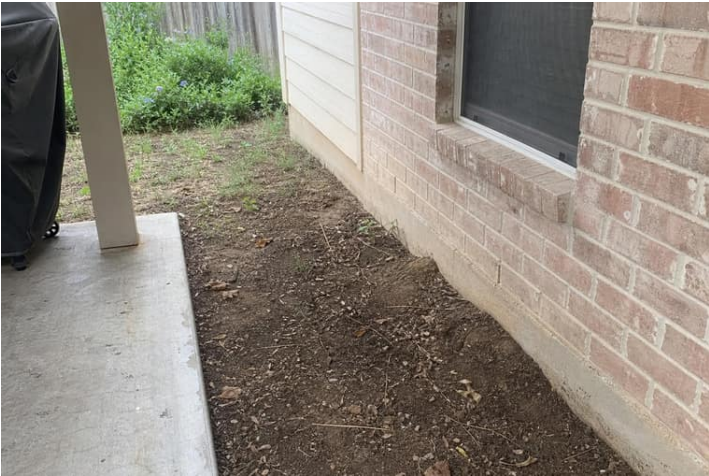
Structural Systems - Soil was observed in direct contact with the lower wall cladding at the rear patio and adjacent exterior flatwork, eliminating the intended clearance between grade and wall materials and increasing the potential for moisture intrusion and water intrusion toward the foundation.

Soil was in contact with the lower wall cladding at the rear patio and flatwork. Corrective grading is recommended to provide clearance at wall materials and direct surface water away from the foundation.

Soil contact and drainage clearance concern at the rear patio.

Regrade and adjust flatwork/soil levels at the rear patio to restore proper clearance at wall cladding and ensure surface water is directed away from the foundation.

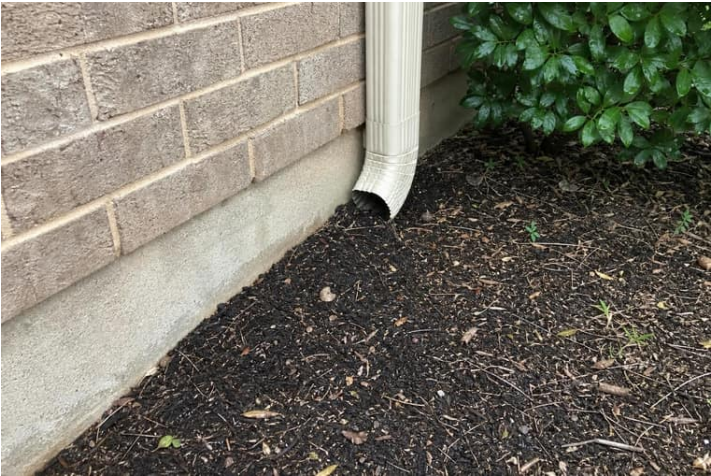
Downspout discharging near the foundation with limited clearance.

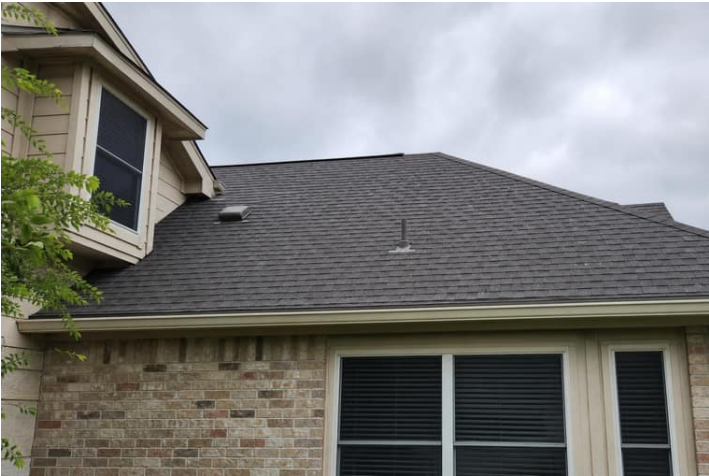
Composition shingle roof covering viewed from accessible ground and eave areas.

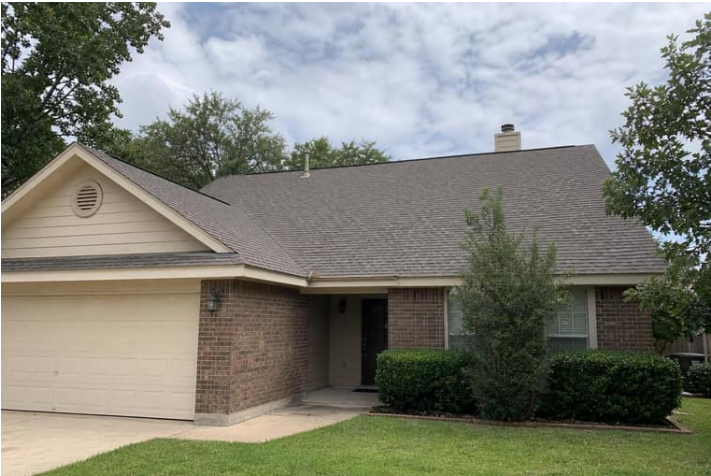
Front roof slope viewed from a safe ground-level vantage.

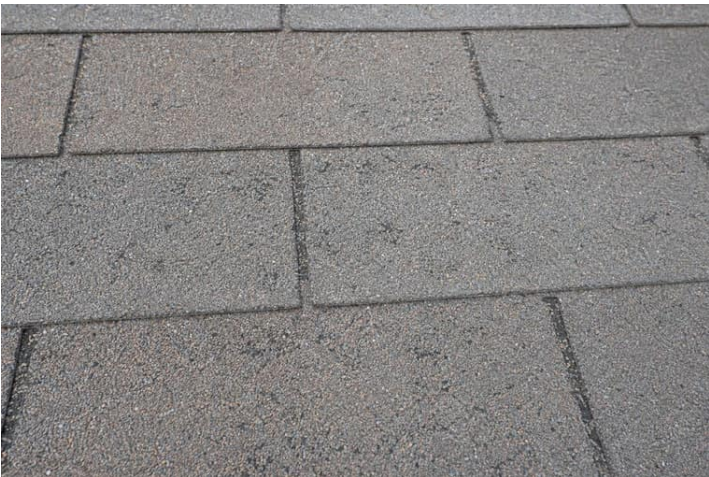
Localized shingle granule loss and surface wear.

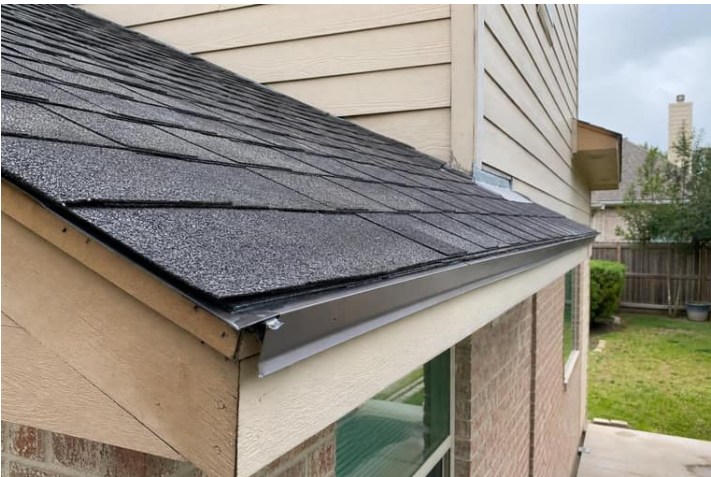
Eave and flashing transition detail at ladder height.

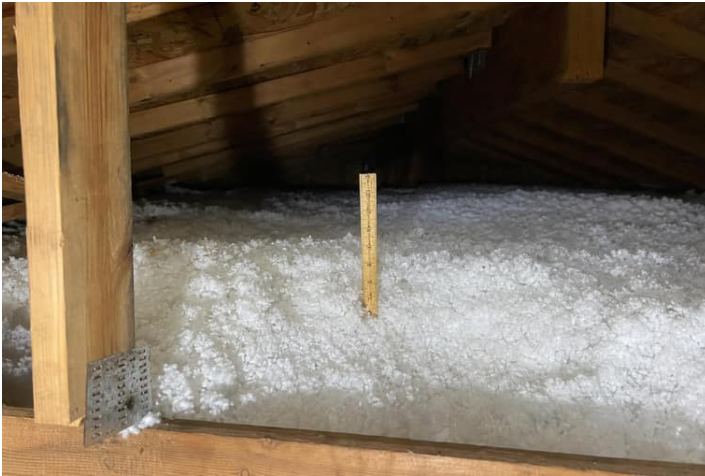
Structural Systems - Attic framing was inspected from the attic access. Insulation depth averaged approximately 8 inches in visible areas, which is below current commonly recommended levels for this climate.

Accessible attic framing was inspected from the attic access. Insulation depth averaged approximately 8 inches in visible areas, which is below current commonly recommended levels; adding insulation after air sealing is recommended.

Accessible attic insulation depth documentation.

Add insulation after air sealing accessible attic areas to improve energy performance.

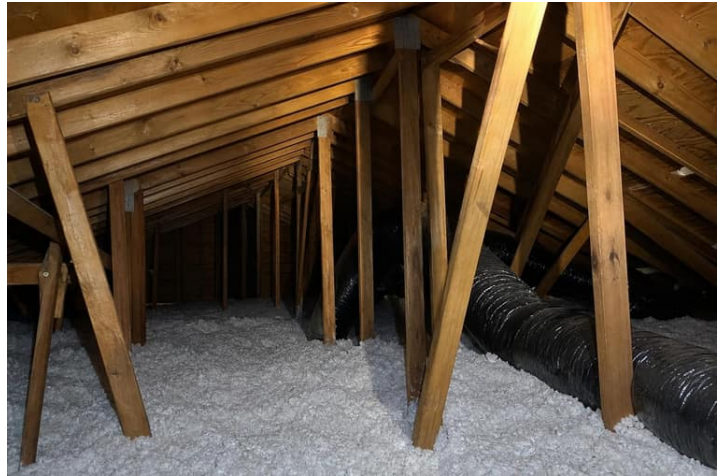
Accessible attic framing and roof decking from the attic access.

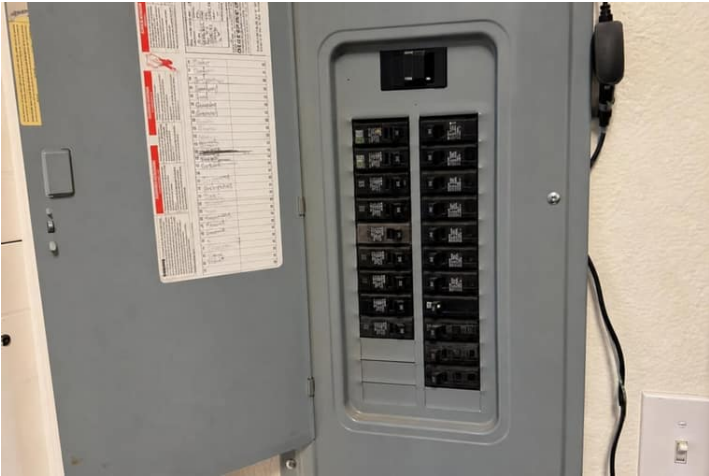
Electrical Systems - The panel directory was incomplete, limiting the ability to identify circuits, and one exterior receptacle did not respond to GFCI testing, indicating a loss of shock protection at that location.

Representative receptacles and fixtures were tested. The panel directory was incomplete and one exterior receptacle did not respond to GFCI testing. Evaluation and correction by a qualified electrical contractor is recommended.

Electrical branch circuit concern with incomplete panel labeling.

Evaluation and correction by a qualified electrical contractor is recommended, including completing the panel directory and repairing or replacing the non-responsive GFCI protection.

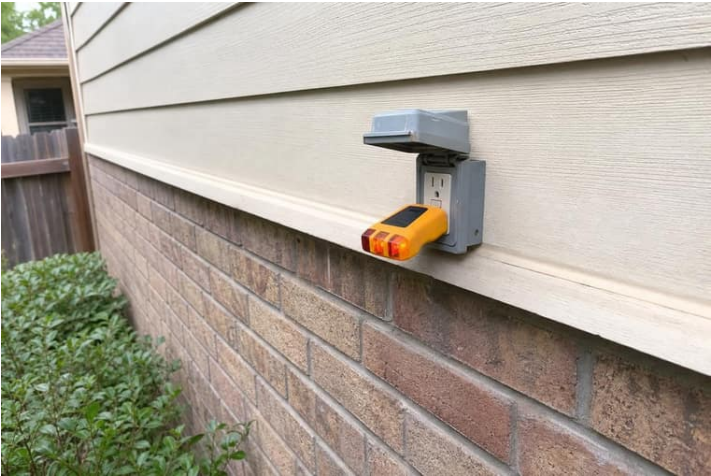
Exterior receptacle that did not respond to GFCI testing.

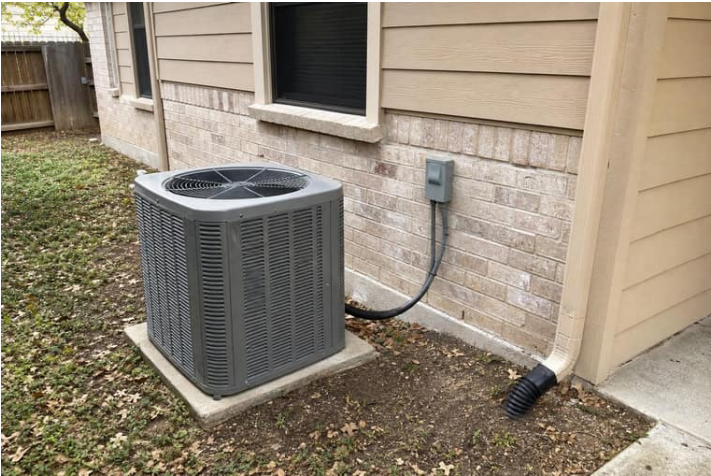
Heating equipment overview for the Texas REI QA report.

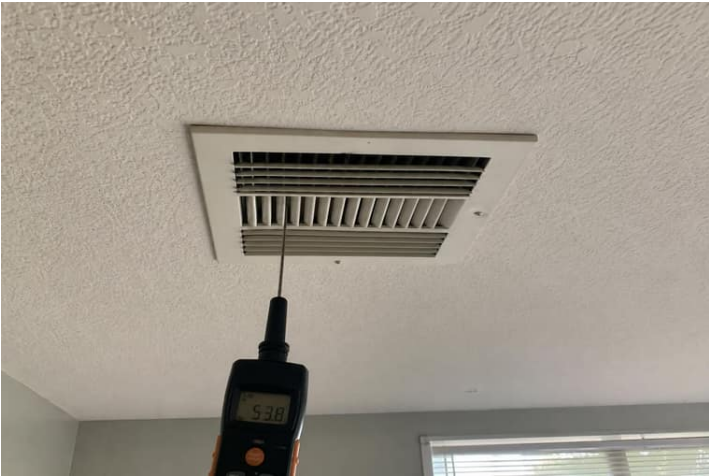
Heating, Ventilation, and Air Conditioning Systems - The split-system central air conditioner was operated with normal controls, and the measured temperature differential between return and supply air was approximately 13 F, below the typical 15 to 20 F target range, indicating reduced cooling performance.

Cooling equipment was operated with normal controls. Temperature differential measured approximately 13 F between the return and supply air, which is below the typical 15 to 20 F target range; servicing by a licensed HVAC contractor is recommended.

Supply register temperature check showing low cooling differential.

Servicing by a licensed HVAC contractor is recommended to evaluate refrigerant charge, airflow, and overall system performance.

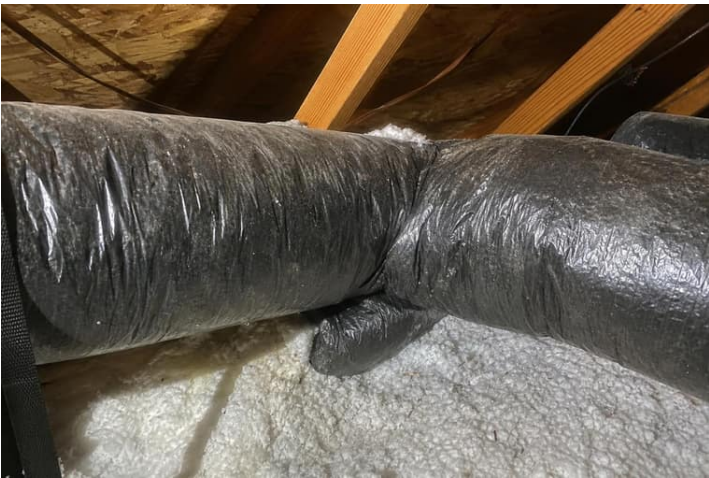
Heating, Ventilation, and Air Conditioning Systems - Several flexible attic ducts were found in contact with each other, and insulation was compressed at one branch run, conditions that can promote condensation and restrict airflow.

Visible flexible ductwork was inspected in accessible attic areas. Several ducts were in contact with each other and insulation was compressed at one branch run; separating and supporting the ducts is recommended to reduce condensation risk and improve airflow.

Flexible attic ducts in contact with compressed insulation at one branch.

Separate and properly support the affected ductwork to reduce condensation risk and improve airflow.

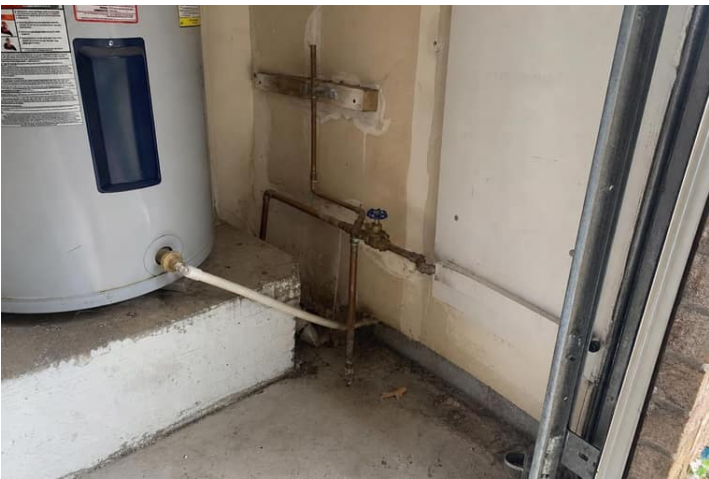
Main water supply valve and visible supply piping documentation.

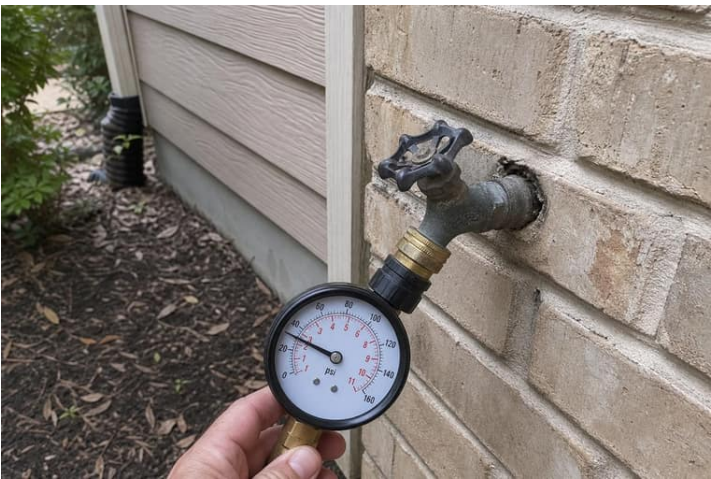
Plumbing Systems - Static water pressure measured approximately 32 psi at the exterior hose bibb, lower than typical residential pressure, and anti-siphon (backflow prevention) protection was missing at two exterior faucets.

FINDINGS / COMMENTS  
Visible supply distribution piping and representative fixtures were inspected. Static water pressure measured approximately 32 psi at the exterior hose bibb, which is lower than typical residential pressure, and anti-siphon protection was missing at two exterior faucets. Evaluation and correction by a qualified plumber is recommended.

Static water pressure reading at an exterior hose bibb lacking anti-siphon protection.

Evaluation and correction by a qualified plumber is recommended, including assessment of the pressure condition and installation of anti-siphon devices at the affected exterior faucets.

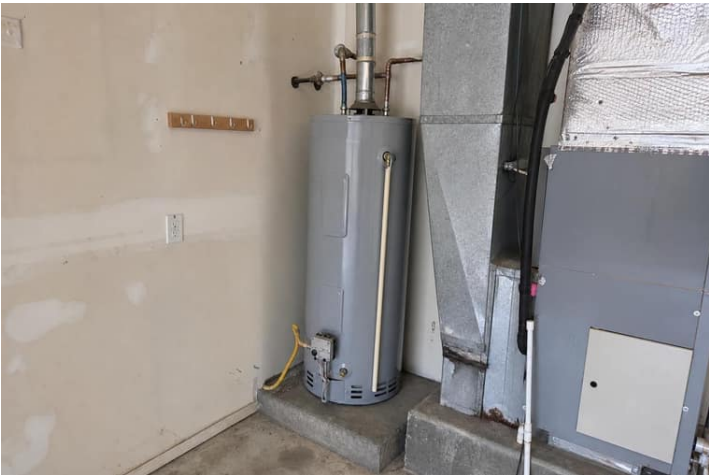
Natural-gas water heater overview with visible supply and venting connections.

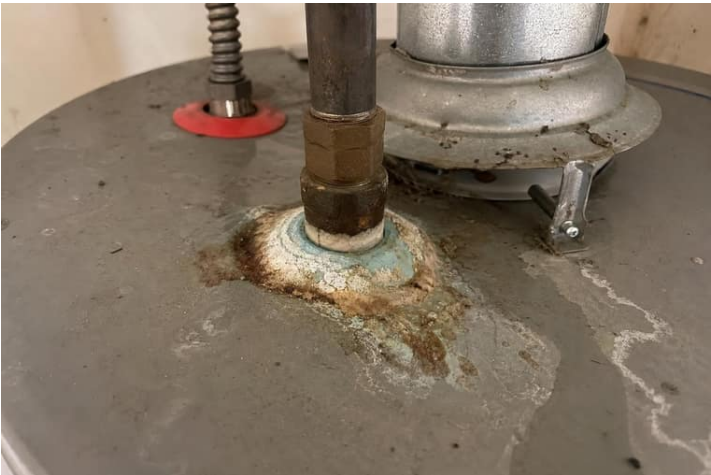
Plumbing Systems - Hot water temperature measured approximately 134 F at the kitchen sink, above commonly recommended scald-safety levels, and corrosion was observed at the cold-water supply connection at the water heater.

Water heating equipment was inspected from accessible areas. Hot water temperature measured approximately 134 F at the kitchen sink and corrosion was observed at the cold-water supply connection; adjustment and repair by a qualified plumber is recommended.

Corrosion and mineral staining at the cold-water supply connection.

Adjustment of the water heater thermostat setting and repair of the corroded supply connection by a qualified plumber is recommended.

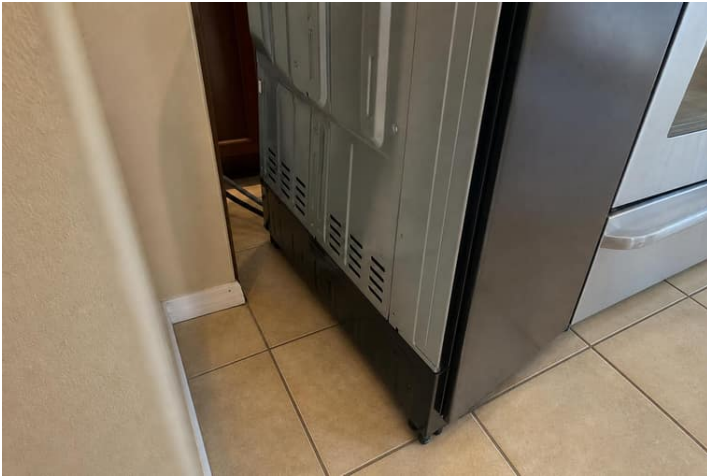
Appliances - The presence and proper installation of the range anti-tip bracket could not be verified, which is a recognized safety feature intended to prevent the range from tipping forward.

Range anti-tip bracket was not verified and should be corrected for safety.

Range anti-tip bracket was not verified.

Verify installation of the anti-tip bracket and correct as needed for safety.

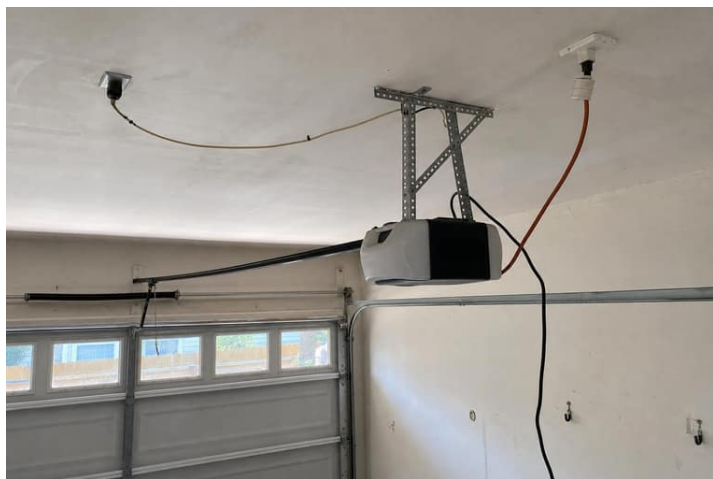
Appliances - The garage door operator responded to normal controls and the photo-eye reverse function operated correctly; however, the opener was found powered through an extension cord/power strip arrangement, which is not suitable as permanent wiring.

The garage door operator responded to normal controls and the photo-eye reverse function operated. The opener was powered through an extension cord/power strip arrangement, which is not suitable as permanent wiring; correction by a qualified contractor is recommended.

Garage door opener powered through an extension cord rather than a dedicated outlet.

Correction by a qualified contractor is recommended to provide a dedicated, permanent power connection for the garage door operator.

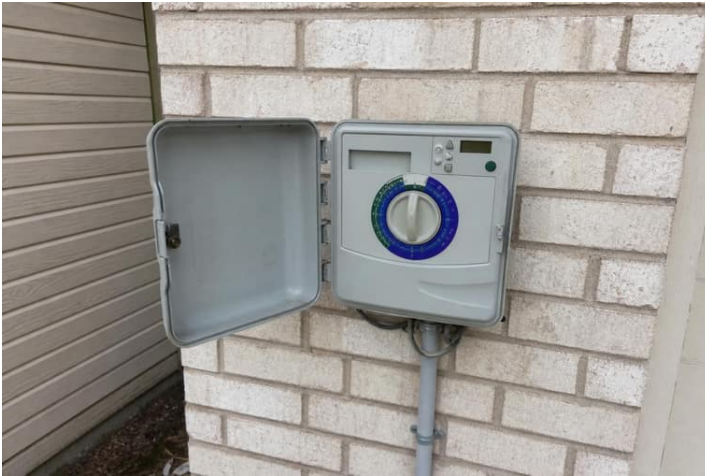
Optional Systems - Zone labels were not present at the irrigation controller, one sprinkler head in the front bed was observed bubbling from below grade, and one rear-yard head sprayed vertically rather than in its intended pattern, indicating misaligned or damaged components.

The landscape irrigation system was operated manually at the controller. Zone labels were not present at the timer, one head in the front bed bubbled from below grade, and one rear-yard head sprayed vertically; adjustment and repair by a qualified irrigation contractor is recommended.

Irrigation controller with missing zone labels.

Adjustment and repair by a qualified irrigation contractor is recommended, including labeling controller zones and correcting the malfunctioning sprinkler heads.

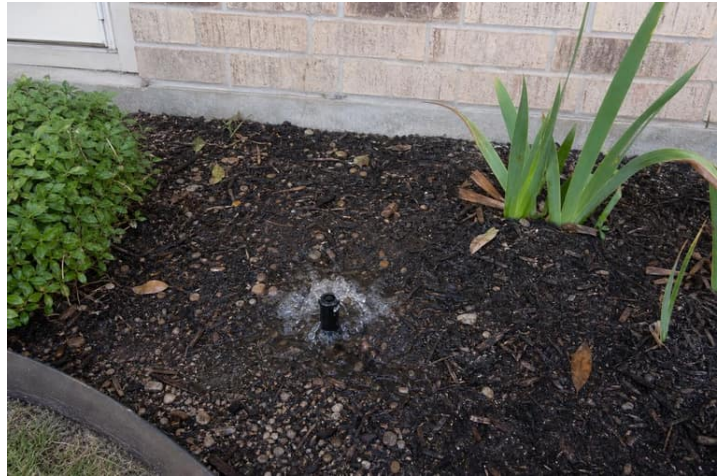
Sprinkler head bubbling from below grade during the manual zone test.
