Whole House Inspection Report

May 29, 2026

1208 Cedar Hollow Lane Customer Demo 20260530-010437-664, Austin, TX 78704

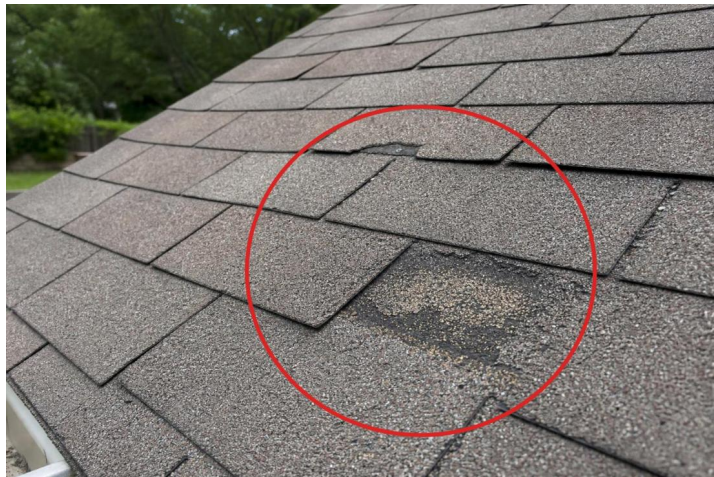
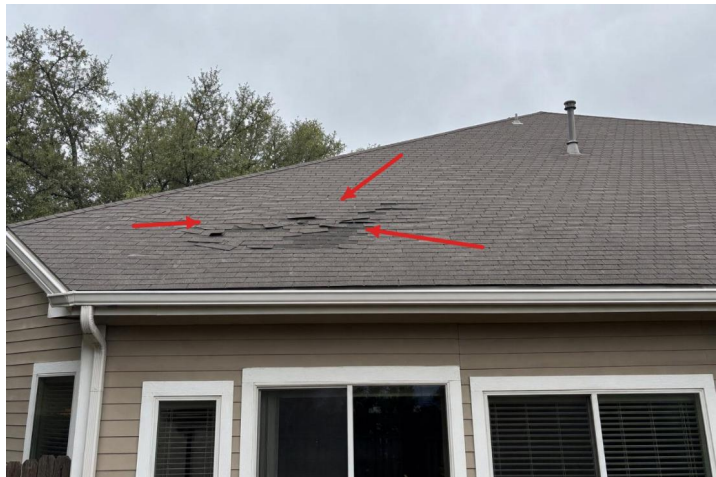
Roof - Damaged, lifted, and worn shingles were observed at the rear slope.

Status: inspected
Defects: Damaged/missing shingles
Notes: Damaged, lifted, and worn shingles were observed at the rear slope. Recommend evaluation and repair by a qualified roofing contractor before closing.

Roof 1.1a - Roof-covering materials

Roof 1.1b - Roof-covering materials

Evaluation and repair by a qualified roofing contractor is recommended before closing to prevent moisture intrusion.

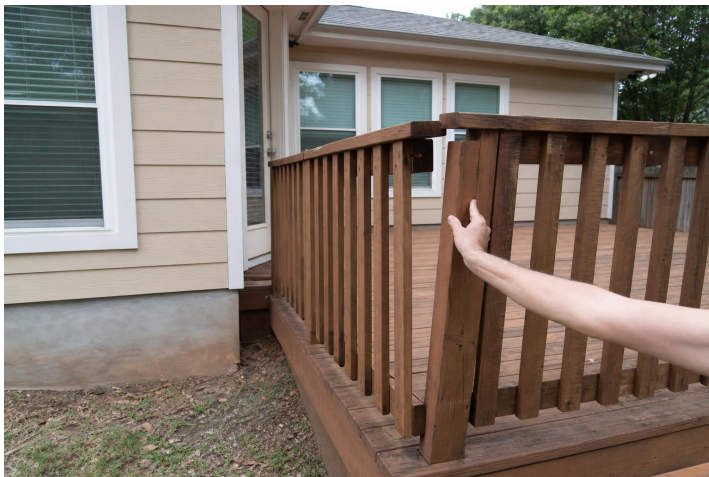
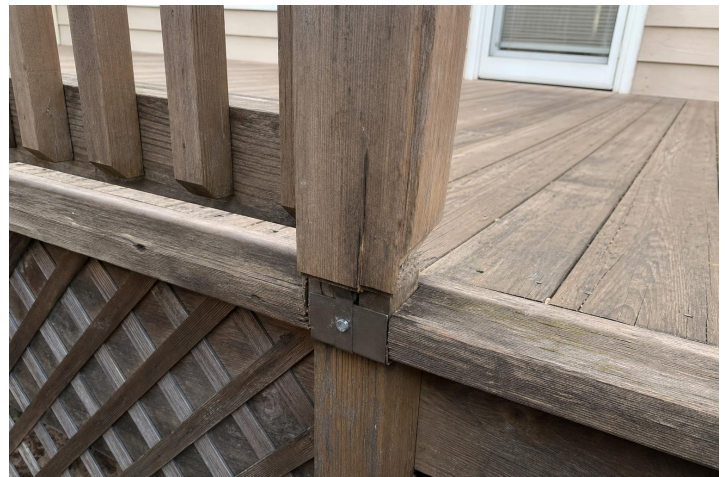
Exterior - The guardrail at the east corner of the rear deck moved under light lateral pressure, indicating an unstable or inadequately anchored post.

Notes: Rear deck guardrail moved under light pressure at the east corner. Recommend repair by a qualified contractor for safety.

Exterior 2.8a - Rear deck guardrail at the loose east corner.

Exterior 2.8b - Closer view of guardrail post movement at the rear deck.

Repair by a qualified contractor is recommended to restore guardrail stability and prevent fall hazard.

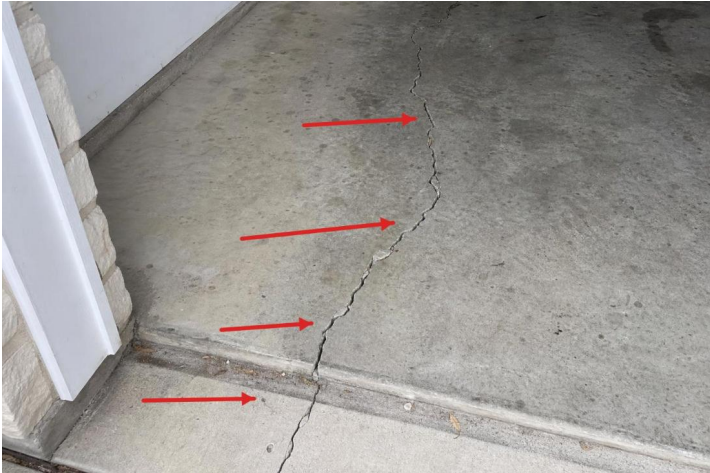
Basement, Foundation, Crawlspaces & Structure 3.7a - Foundation movement indicators

Basement, Foundation, Crawlspace & Structure - A visible crack and minor differential movement indicators were observed at the garage slab.

Status: inspected
Defects: Unlevel floors observed
Notes: A visible garage slab crack and minor differential movement indicators were observed. Recommend monitoring and evaluation by a qualified foundation specialist if movement continues.

Monitor the area for changes. If movement continues or worsens, evaluation by a qualified foundation specialist is recommended.

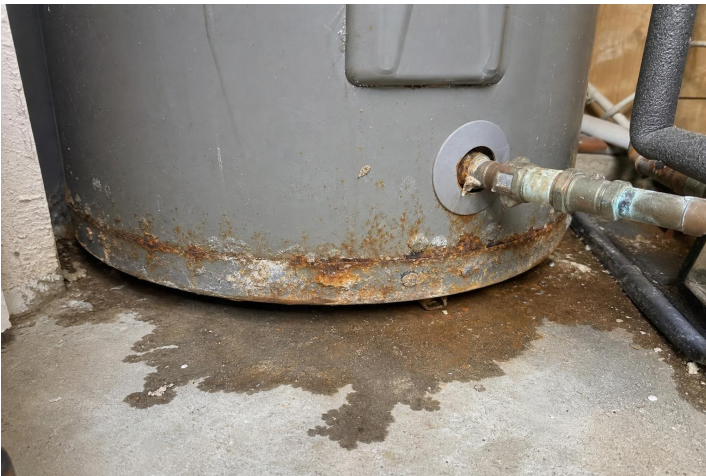
Plumbing - Corrosion was visible near the lower water heater jacket and connections. The unit (manufactured 2011) is near the end of its typical service life.

Notes: Corrosion was visible near the lower water-heater jacket and connections. The unit is also near the end of typical service life; recommend plumbing evaluation.

Plumbing 6.3a - Water heater corrosion visible near the lower jacket and connections.

Evaluation by a qualified plumber is recommended. Budgeting for replacement in the near term is advised given the unit's age and observed corrosion.

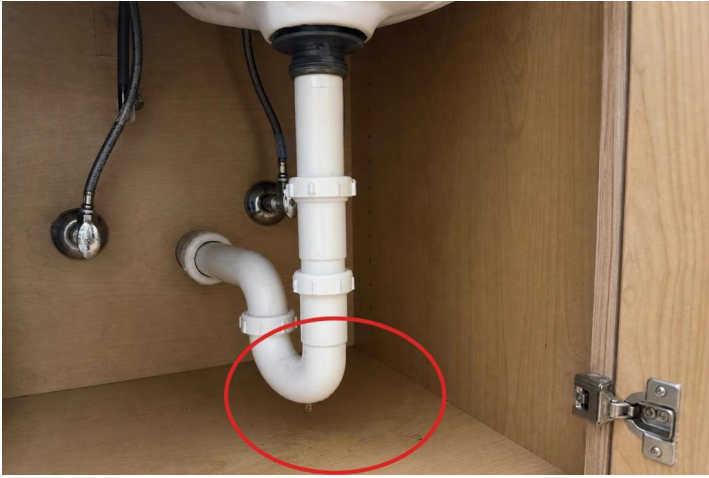
Plumbing 6.11a - Active plumbing leaks observed

Plumbing - A minor active drip was observed at the guest bathroom sink trap during fixture operation.

Notes: A minor active drip was observed at the guest bathroom sink trap during fixture operation. Recommend repair by a qualified plumber.

Repair by a qualified plumber is recommended to eliminate the active drain leak.

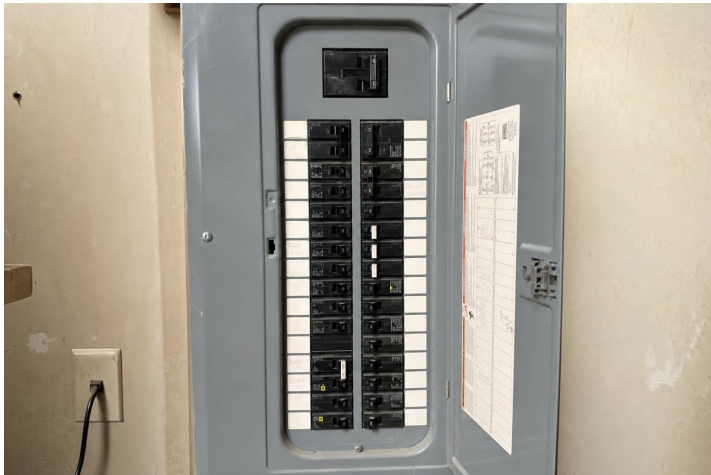
Electrical - Several breakers in the service panel were not clearly or accurately labeled.

Electrical 7.5a - Electrical panel with incomplete breaker labeling.

A qualified person should accurately label all circuits to facilitate safe maintenance and emergency shutoff.

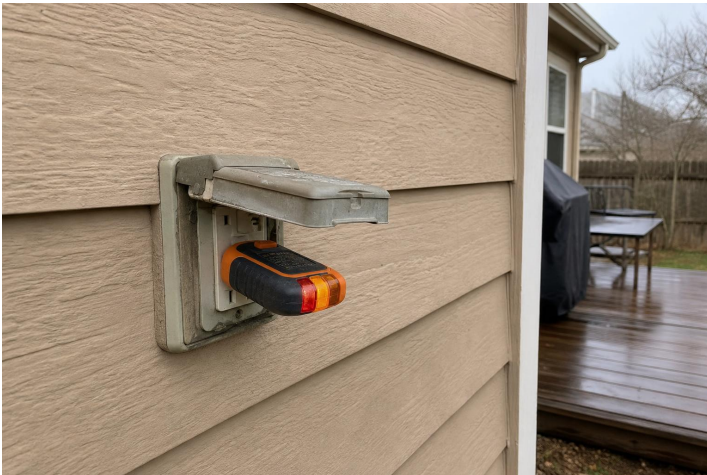
Electrical - One exterior receptacle did not trip when tested with a GFCI tester.

Notes: One exterior receptacle did not trip when tested with a GFCI tester. Recommend correction by a qualified electrician.

Electrical 7.9a - Exterior receptacle that did not trip during GFCI testing.

Correction by a qualified electrician is recommended. GFCI protection at exterior locations is required for personal safety.

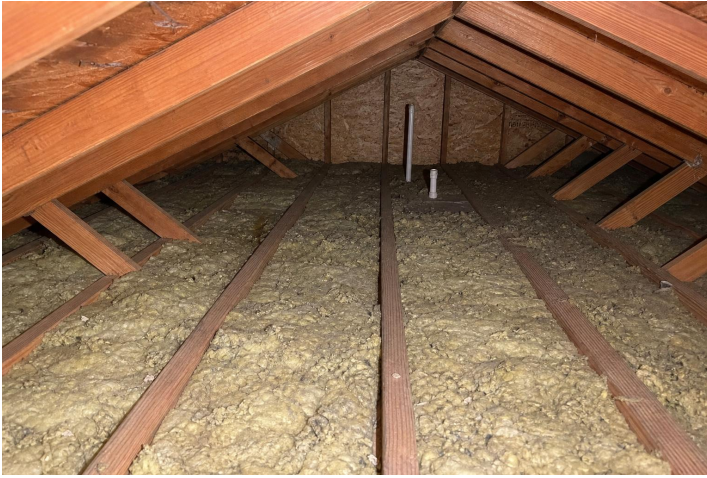
Attic, Insulation & Ventilation - Blown fiberglass insulation depth of 10–13 inches was observed to be below common modern energy-efficiency targets in portions of the attic.

Notes: Insulation depth was below common modern energy-efficiency targets in portions of the attic. Recommend improving insulation coverage for comfort and efficiency.

Attic, Insulation & Ventilation 9.1a - Attic insulation depth below modern energy-efficiency targets.

Improving insulation coverage is recommended for enhanced energy efficiency and interior comfort.

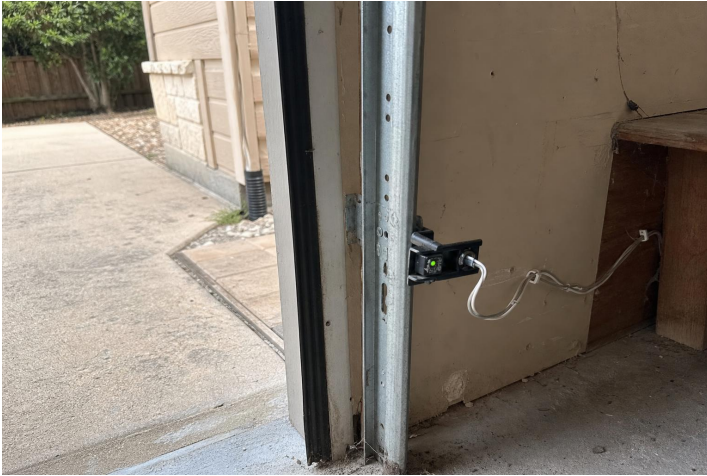
Doors, Windows & Interior - The garage door photo-eye sensors did not respond consistently when the safety beam was interrupted during testing.

Doors, Windows & Interior 10.8a - Garage photo-eye sensors did not respond consistently when tested.

Adjustment or repair by a qualified garage door contractor is recommended. Functioning photo-eye sensors are a critical entrapment-prevention safety feature.

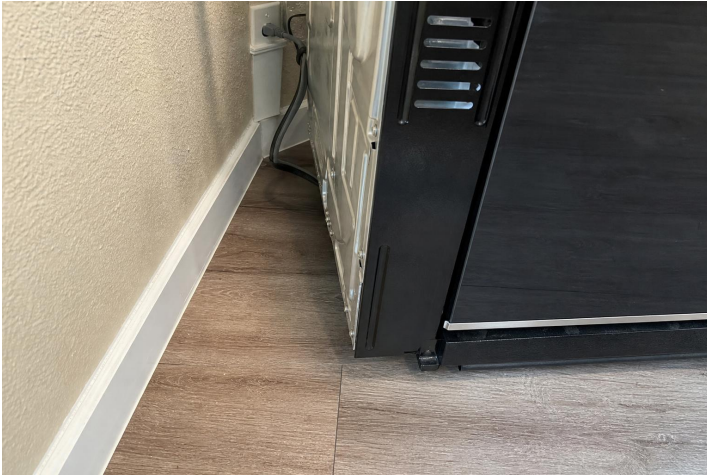
Optional Systems & Components - An anti-tip bracket for the range was not confirmed to be installed during the inspection.

Notes: Range anti-tip bracket was not verified. Recommend installing or confirming an anti-tip device for safety.

Optional Systems & Components 11.2a - Range anti-tip bracket was not verified.

Install or confirm the presence of an anti-tip device to prevent the range from tipping forward, which poses a burn and crush hazard.
