# WHOLE HOUSE INSPECTION REPORT

**1208 Cedar Hollow Lane Customer Demo 20260620-232603-144**

Austin, TX 78704

Inspected on Jun 19, 2026

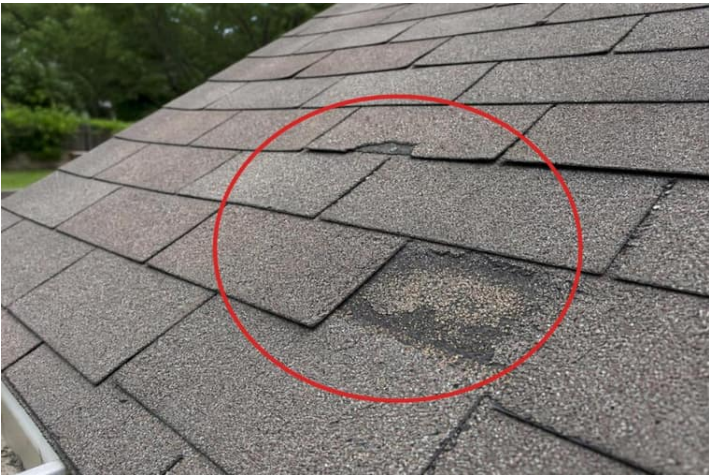
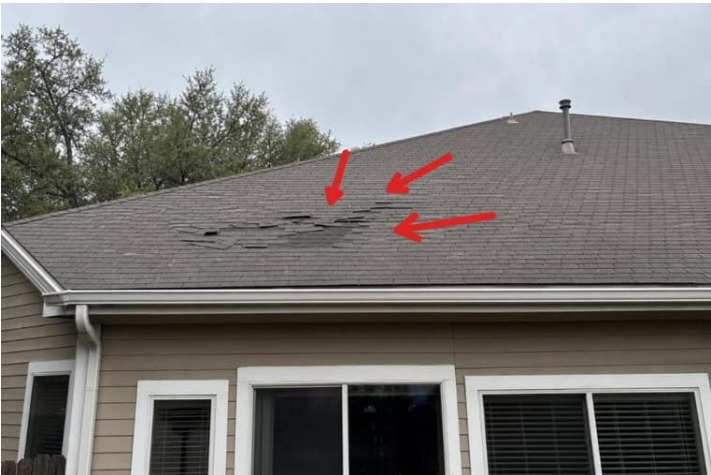
Roof - Damaged, lifted, and worn shingles were observed at the rear slope of the roof.

Status: inspected  
Defects: Damaged/missing shingles  
Notes: Damaged, lifted, and worn shingles were observed at the rear slope. Recommend evaluation and repair by a qualified roofing contractor before closing.

Evaluation and repair by a qualified roofing contractor is recommended before closing to prevent water intrusion.

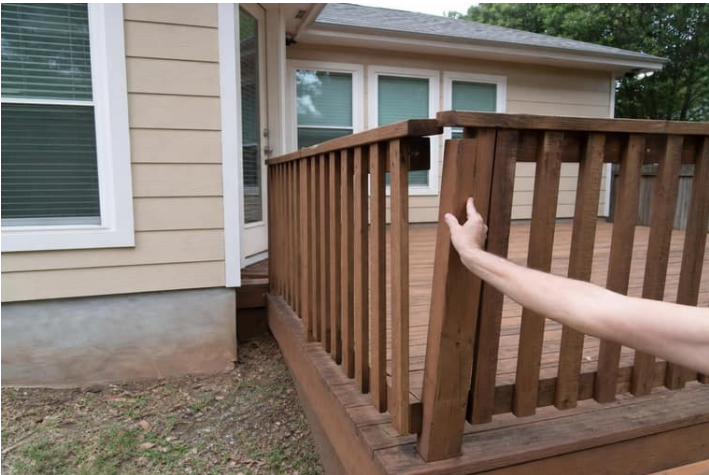
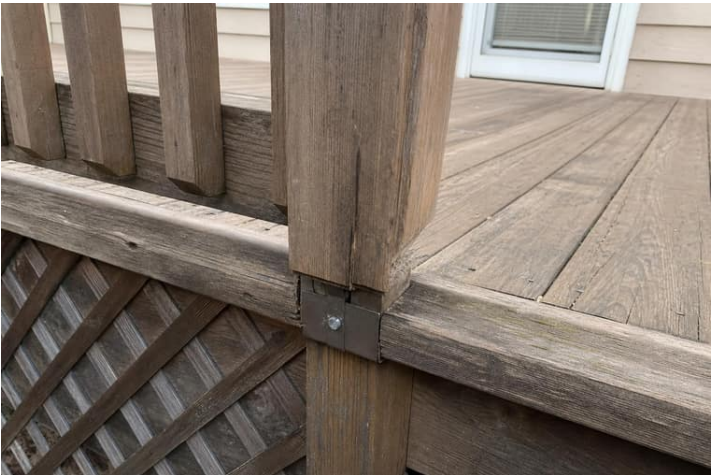
Exterior - The guardrail moved under light pressure at the east corner of the rear deck, indicating an unstable or inadequately secured post.

| <div><div>Railings, guards &amp; handrails</div><div>Status: inspected</div><div>Defects: Unstable/wobbly</div><div>Notes: Rear deck guardrail moved under light pressure at the east corner. Recommend repair by a qualified contractor for safety.</div></div> | CORRECTION NEEDED |

Exterior 2.8a - Rear deck guardrail at the loose east corner.

Exterior 2.8b - Closer view of guardrail post movement at the rear deck.

Repair by a qualified contractor is recommended to ensure the guardrail provides the fall protection for which it is designed.

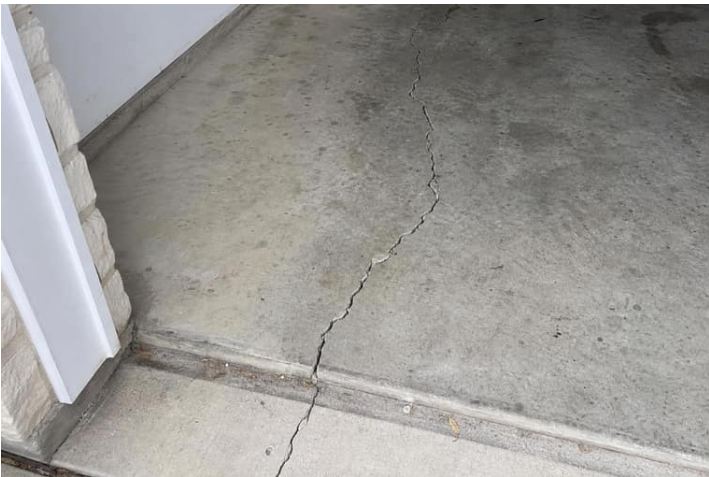
Basement, Foundation, Crawlspace & Structure - A visible crack and minor differential movement indicators were observed in the garage slab.

Notes: A visible garage slab crack and minor differential movement indicators were observed. Recommend monitoring and evaluation by a qualified foundation specialist if movement continues.

Basement, Foundation, Crawlspace & Structure 3.7a - Garage slab crack and minor differential movement indicator.

Monitor the condition; if movement continues or widens, evaluation by a qualified foundation specialist is recommended.

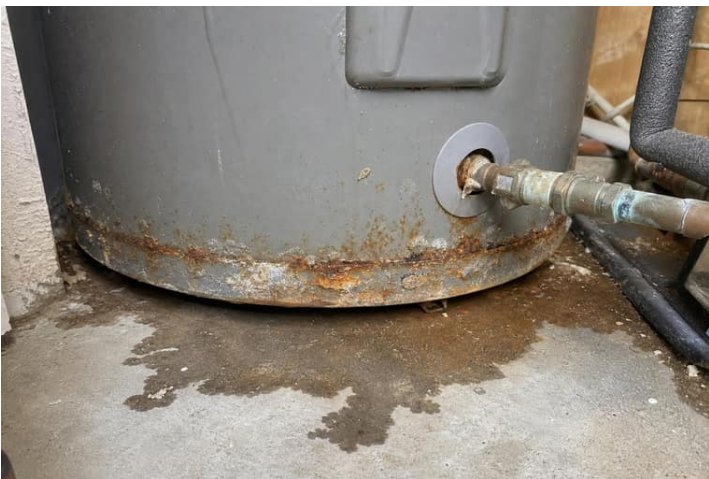
Plumbing - Corrosion was visible near the lower water-heater jacket and connections on the 2011-manufactured 50-gallon gas tank water heater. The unit is approaching or at the end of its typical service life.

| <b>Water heater — energy source, venting, TPR valve, seismic bracing</b><br><br>Status: inspected<br>Defects: Corrosion/deterioration<br>Notes: Corrosion was visible near the lower water-heater jacket and connections. The unit is also near the end of typical service life; recommend plumbing evaluation. | CORRECTION NEEDED |

Plumbing 6.3a - Water heater corrosion visible near the lower jacket and connections.

Evaluation by a qualified plumber is recommended. Budgeting for replacement in the near term is advised given the unit's age and observed corrosion.

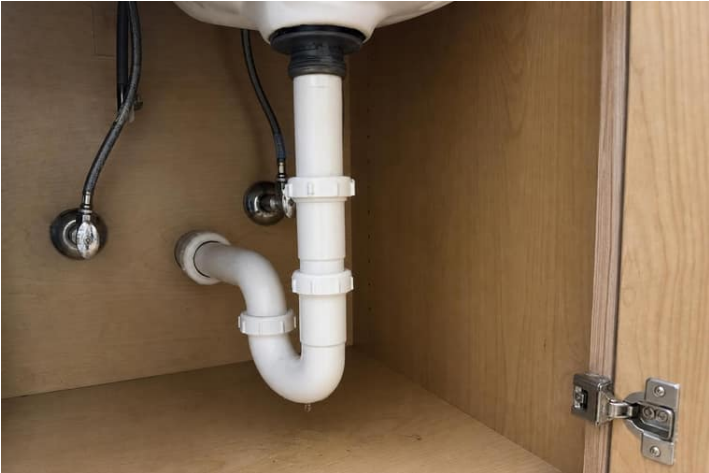
Plumbing - A minor but active drip was observed at the guest bathroom sink trap during fixture operation.

Notes: A minor active drip was observed at the guest bathroom sink trap during fixture operation. Recommend repair by a qualified plumber.

Plumbing 6.11a - Guest bathroom sink trap with active drip noted during operation.

Repair by a qualified plumber is recommended to eliminate the active water leak.

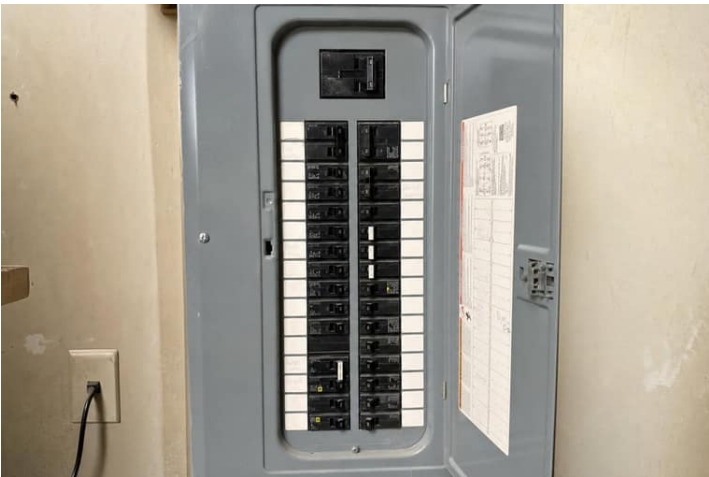
Electrical - Several breakers in the electrical panel were not clearly or accurately labeled.

| <b>Panelboard(s) &amp; overcurrent protection</b><br>Status: inspected<br>Defects: Labeling deficiencies<br>Notes: Several breakers were not clearly labeled, which can delay service or emergency shutoff. Recommend a qualified person accurately label all circuits. | CORRECTION NEEDED |

Electrical 7.5a - Electrical panel with incomplete breaker labeling.

A qualified person should accurately label all circuits to facilitate safe and timely shutoff in routine and emergency situations.

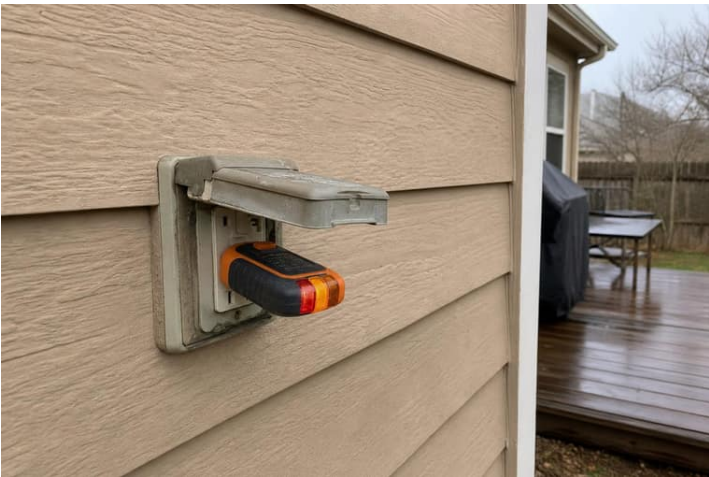
Electrical - One exterior receptacle did not trip when tested with a GFCI tester, indicating the ground-fault protection may not be functioning.

| <p><b>All GFCI receptacles &amp; breakers — tested with GFCI tester</b></p> <p>Status: inspected</p> <p>Defects: GFCI did not trip when tested</p> <p>Notes: One exterior receptacle did not trip when tested with a GFCI tester. Recommend correction by a qualified electrician.</p> | <div>CORRECTION NEEDED</div> |

Electrical 7.9a - Exterior receptacle that did not trip during GFCI testing.

Correction by a qualified electrician is recommended to restore required ground-fault protection at this location.

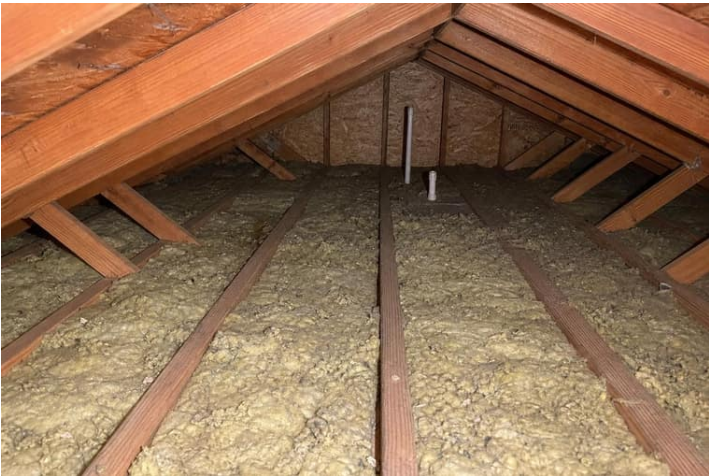
Attic, Insulation & Ventilation - Blown fiberglass insulation measured approximately 10–13 inches in portions of the attic, which is below current energy-efficiency targets in some areas.

Status: inspected  
Defects: Insulation significantly incomplete  
Notes: Insulation depth was below common modern energy-efficiency targets in portions of the attic.  
Recommend improving insulation coverage for comfort and efficiency.

Attic, Insulation & Ventilation 9.1a - Attic insulation depth below modern energy-efficiency targets.

Improving insulation coverage to current recommended levels is advised for improved comfort and energy efficiency.

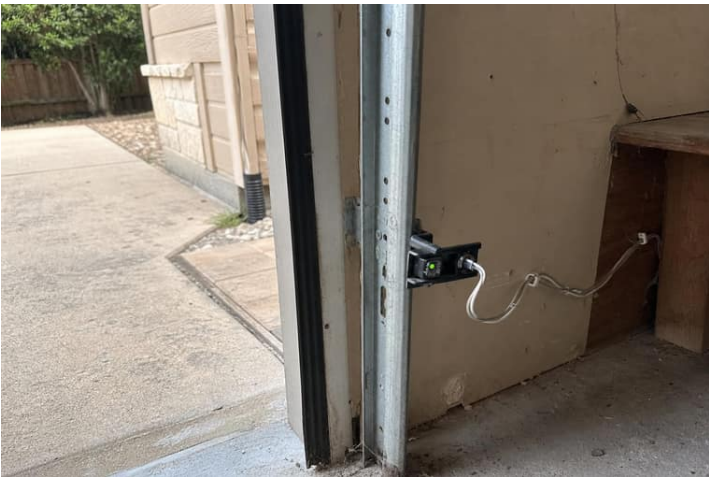
Doors, Windows & Interior - The garage door opener did not reverse properly during safety reversal testing.

| <div>Garage vehicle door(s) &amp; opener — normal controls</div> <div>Status: inspected</div> <div>Defects: Reversal mechanism failure</div> <div>Notes: Garage door opener did not reverse properly during safety testing. Recommend service before regular use.</div> | CORRECTION NEEDED |

Doors, Windows & Interior 10.6a - Garage door photo-eye safety sensor concern.

The opener should be serviced or repaired before regular use to ensure the auto-reverse safety feature functions as intended.

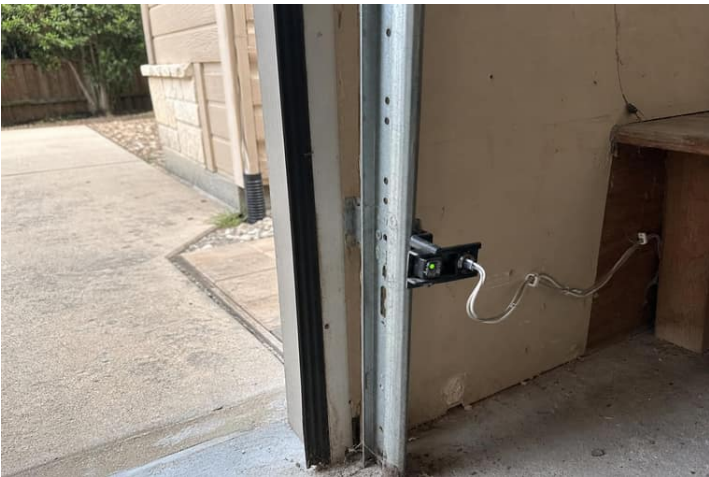
Doors, Windows & Interior - The garage door photo-eye sensors did not respond consistently when the beam was interrupted during testing.

| <p><b>Garage door photo-electric safety sensors did not operate</b></p> <p>Status: inspected</p> <p>Defects: Photo-eye sensors did not trigger reversal</p> <p>Notes: Garage photo-eye sensors did not respond consistently when the beam was interrupted. Recommend adjustment or repair by a qualified garage door contractor.</p> | <div>CORRECTION NEEDED</div> |

Doors, Windows & Interior 10.8a - Garage photo-eye sensors did not respond consistently when tested.

Adjustment or repair by a qualified garage door contractor is recommended to ensure reliable obstruction detection.

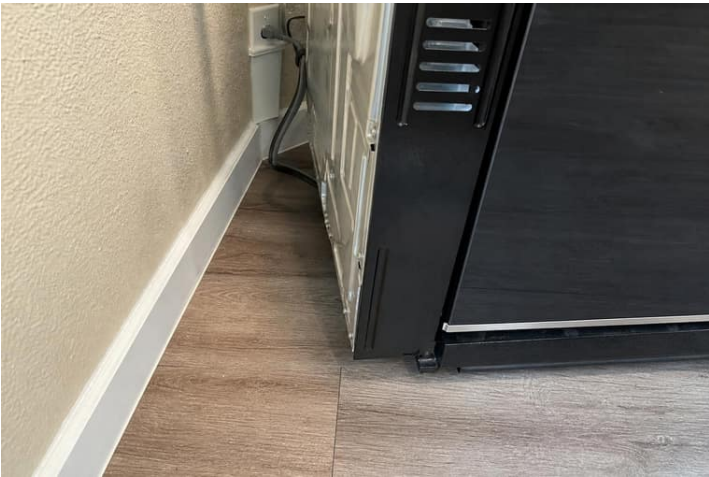
Optional Systems & Components - An anti-tip bracket for the range could not be verified as installed.

Status: inspected  
Defects: Anti-tip bracket absent  
Notes: Range anti-tip bracket was not verified. Recommend installing or confirming an anti-tip device for safety.

Optional Systems & Components 11.2a - Range anti-tip bracket was not verified.

Installing or confirming the presence of an anti-tip device is recommended to prevent the range from tipping forward under load.
