Texas REI Inspection Report

512 Lone Star Trail, Austin, TX 78704

Acme Texas Inspection Services

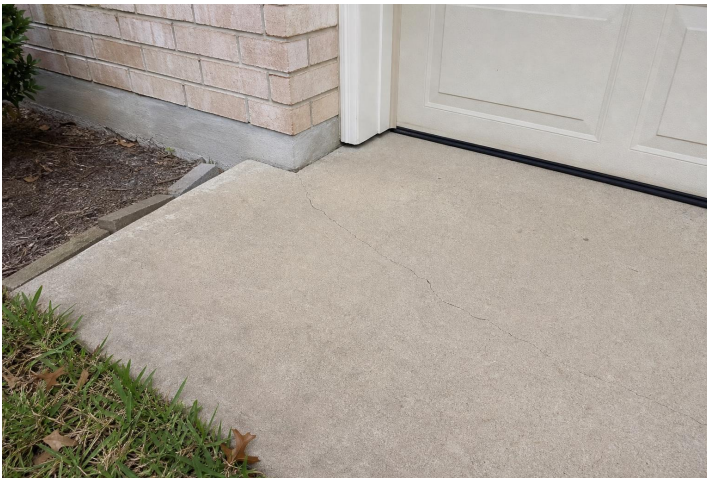
A. Foundations

Visible portions of the slab foundation were inspected. Minor hairline cracking was observed without significant displacement.

Minor hairline foundation cracking without significant displacement. - Minor hairline foundation cracking without significant displacement.

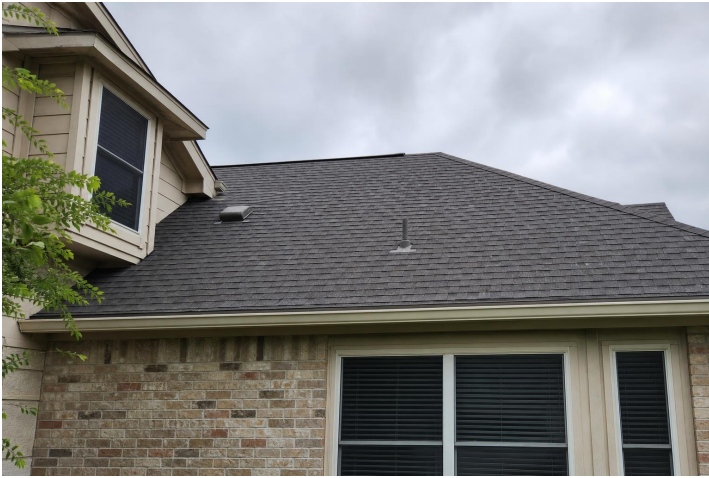
C. Roof Covering Materials

Roof covering materials were inspected from accessible vantage points.

Composition shingle roof covering viewed from accessible ground and eave areas. -
Composition shingle roof covering viewed from accessible ground and eave areas.

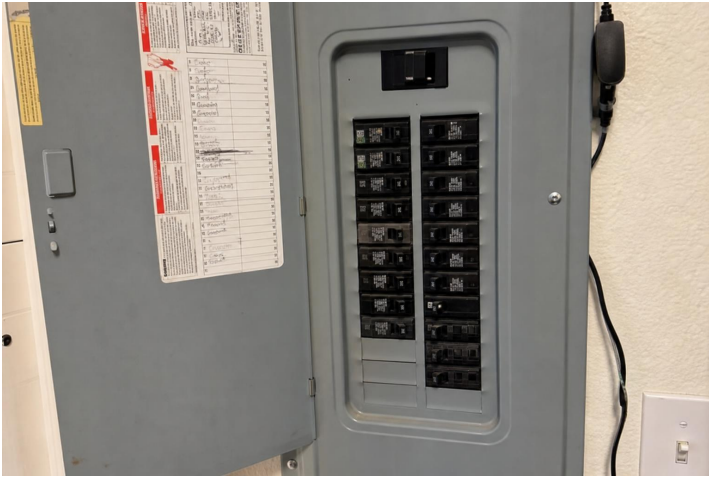
B. Branch Circuits, Connected Devices, and Fixtures

Electrical Systems - Several breakers were not clearly identified and one exterior receptacle did not respond to GFCI testing.

Panel directory labeling was incomplete and one exterior receptacle did not respond to GFCI testing. Further evaluation and correction by a qualified electrical contractor is recommended.

Electrical branch circuit concern with incomplete panel labeling. - Electrical branch circuit concern with incomplete panel labeling.

Have a qualified electrical contractor verify labeling and repair the GFCI concern.

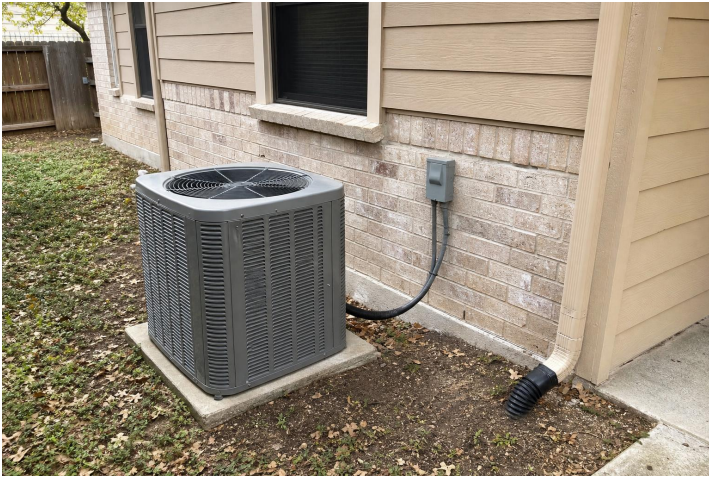
A. Heating Equipment

Heating equipment was operated with normal controls and responded at the thermostat.

Heating and cooling equipment overview for the Texas REI QA report. - Heating and cooling equipment overview for the Texas REI QA report.

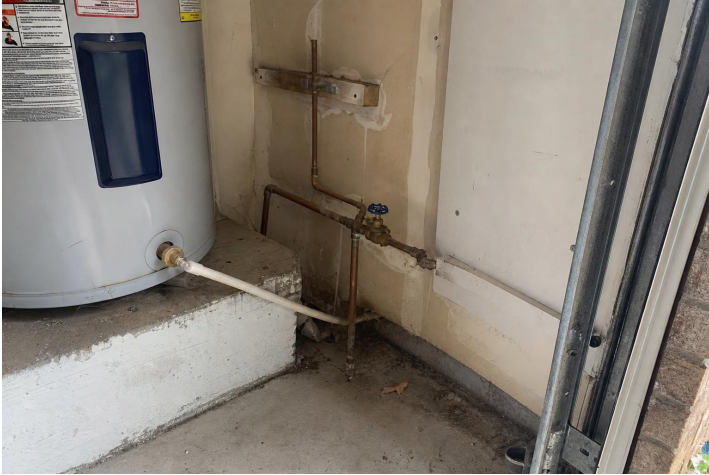
A. Plumbing Supply, Distribution Systems, and Fixtures

Visible supply distribution piping and representative fixtures were inspected.

Main water supply valve and visible supply piping documentation. - Main water supply valve and visible supply piping documentation.

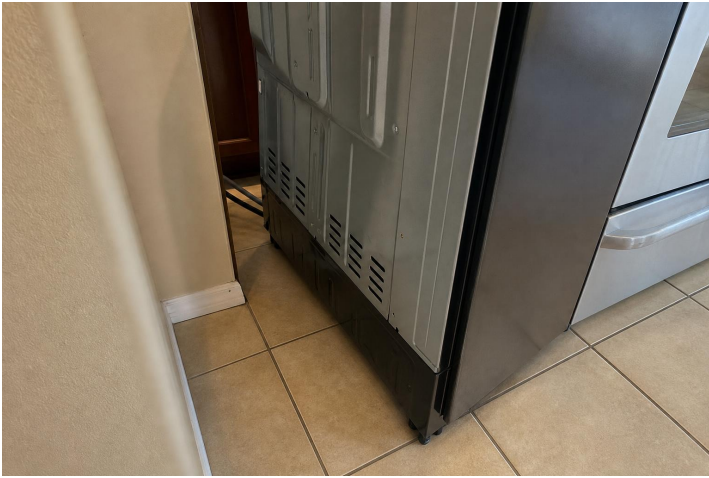
D. Ranges, Cooktops, and Ovens

Appliances - Range anti-tip bracket was not verified.

Range anti-tip bracket was not verified. Install or verify the bracket to improve appliance safety.

Range anti-tip bracket was not verified. - Range anti-tip bracket was not verified.

Install or verify the anti-tip bracket according to the appliance manufacturer instructions.
