# POOL / SPA INSPECTION REPORT

## 888 Bluewater Bend

Norco, CA 78704

Inspected on Jul 10, 2026

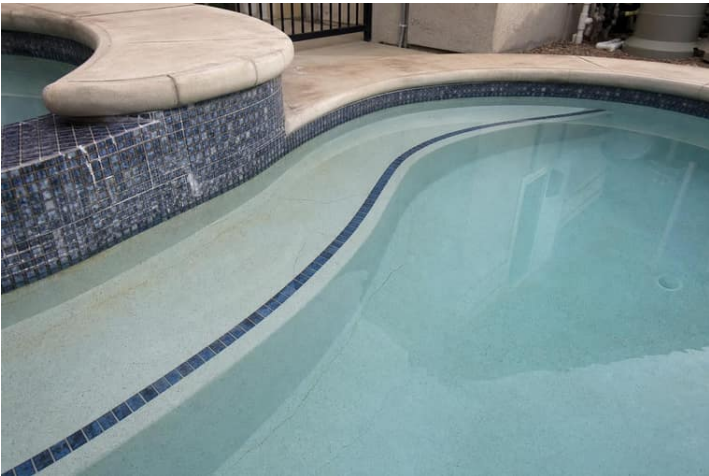
| <b>Pool/spa shell and visible surfaces</b><br><br>Status: inspected<br>Defects: Cracking observed; Staining observed<br>Notes: Hairline cracking and staining were observed at the shallow-end step and waterline tile transition. | <b>CORRECTION NEEDED</b> |

Pool / Spa Structure 1.1a - Pool shell and visible interior surface overview.

Pool / Spa Structure - Hairline cracking and staining were observed at the shallow-end step and waterline tile transition.  
Have the affected shell/tile areas evaluated by a qualified pool surface contractor to determine repair needs and prevent further deterioration.

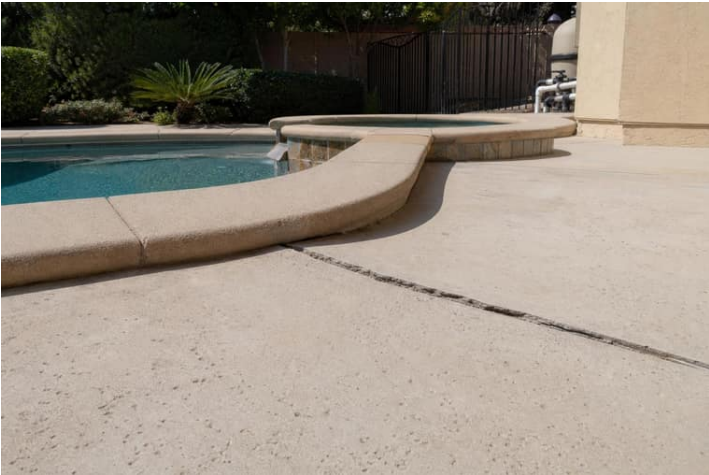
Status: inspected  
Defects: Trip hazard; Cracking  
Notes: Raised cracked deck edge near the north coping created a trip hazard.

Deck and Access 2.1a - Pool deck walking surface and drainage area.

Deck and Access - A raised, cracked deck edge near the north coping created a trip hazard.  
Have the deck edge repaired or leveled by a qualified contractor to eliminate the trip hazard.

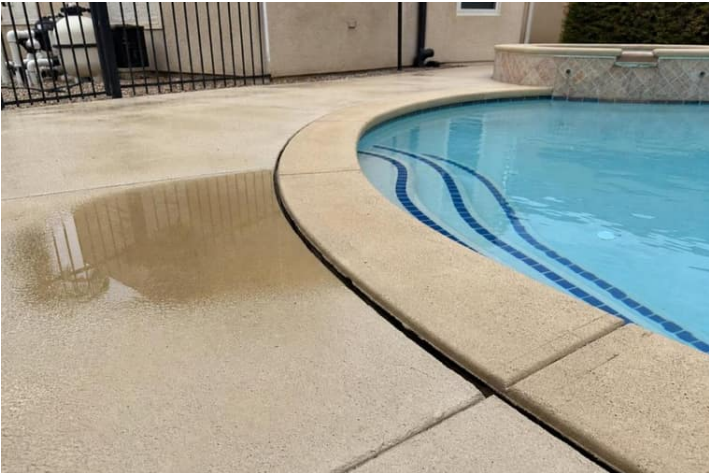
| <div><div>Deck separation and minimum safety standards</div><div>Status: inspected</div><div>Defects: Deck separation concern; Standing puddles</div><div>Notes: Deck separation at the west pool wall was difficult to confirm and standing water was observed near the shallow-end step.</div></div> | <div>CORRECTION NEEDED</div> |

Deck and Access 2.5a - Deck separation and minimum safety standards

Deck and Access - Deck separation at the west pool wall was difficult to confirm, and standing water/puddles were observed near the shallow-end step.  
Have a qualified pool contractor further evaluate deck separation at the west wall and correct the drainage condition causing standing water at the shallow-end step.

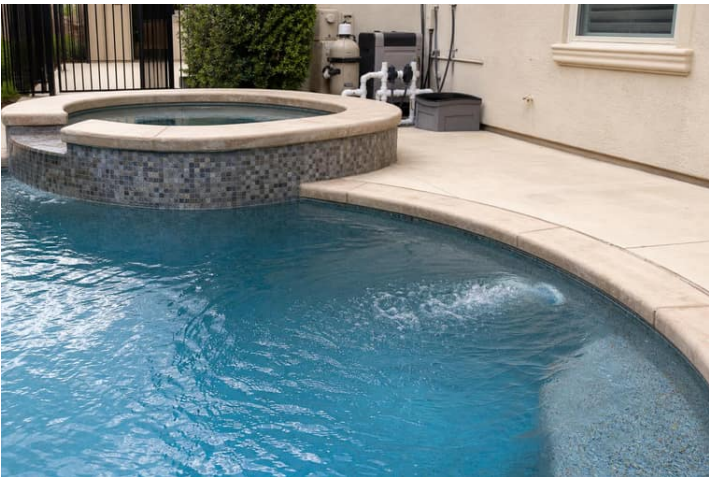
Water Flow and Circulation 3.1a - Return flow observed during basic circulation check.

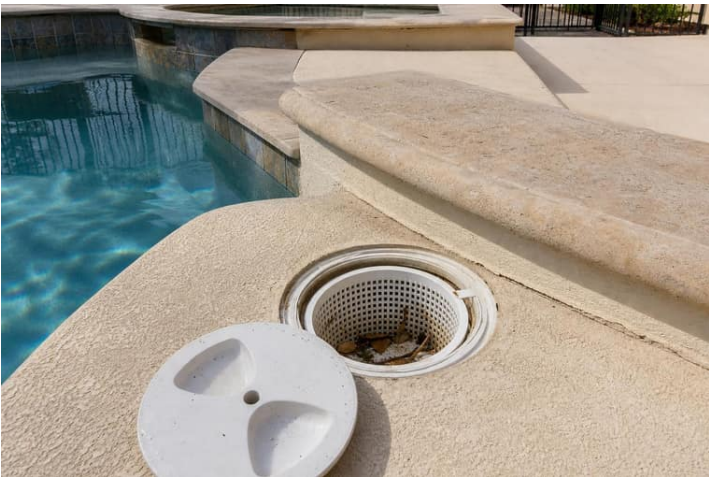
Drains, Covers, and Returns 4.2a - Skimmer basket and visible skimmer condition.

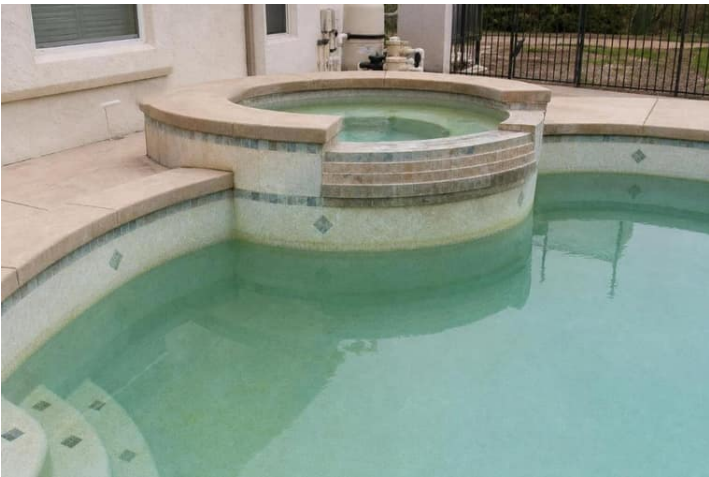
Notes: Water was slightly cloudy with visible algae staining at the spa spillway and shallow-end wall.

Water Quality and Appearance 5.1a - Water clarity and visible appearance

Water Quality and Appearance - Water was slightly cloudy with visible algae staining at the spa spillway and shallow-end wall.  
Have the pool water balanced, shocked, and filtered by a qualified pool service professional to restore clarity and address algae staining.

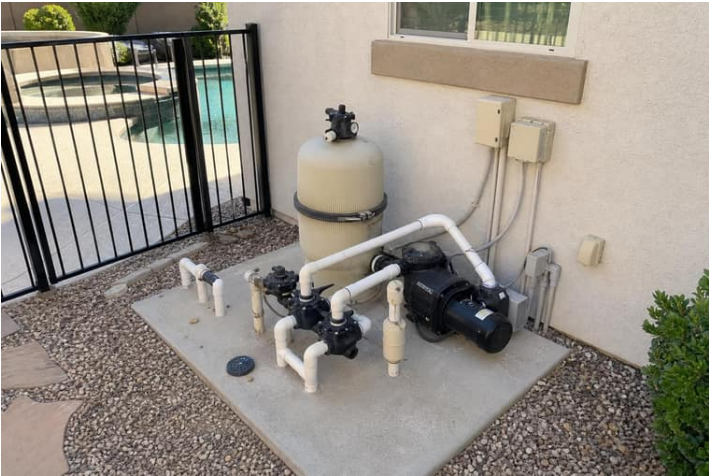
Status: inspected  
Defects: Active leak; Excessive noise  
Notes: Pump operated with a minor active drip at the union and louder-than-typical bearing noise.

Pump, Filtration, and Plumbing 6.1a - Pump and equipment pad overview.

Pump, Filtration, and Plumbing - The pump operated with a minor active drip at the union and louder-than-typical bearing noise.  
Have a licensed pool equipment technician repair the union leak and inspect/service the pump bearings.

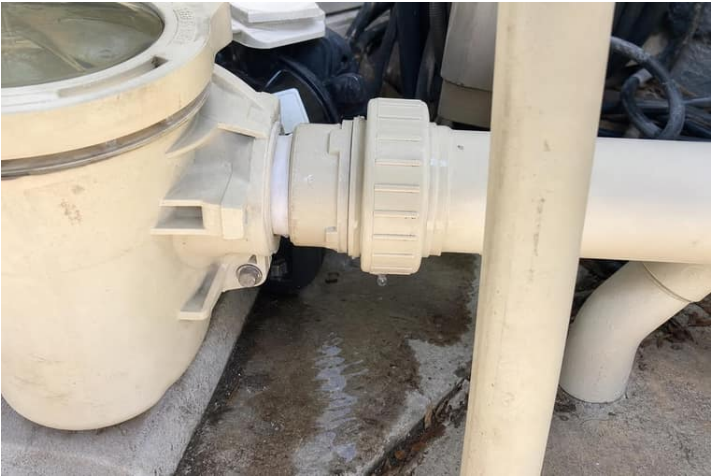
Pump, Filtration, and Plumbing 6.1b - Close view of pump union area where minor dripping was observed.

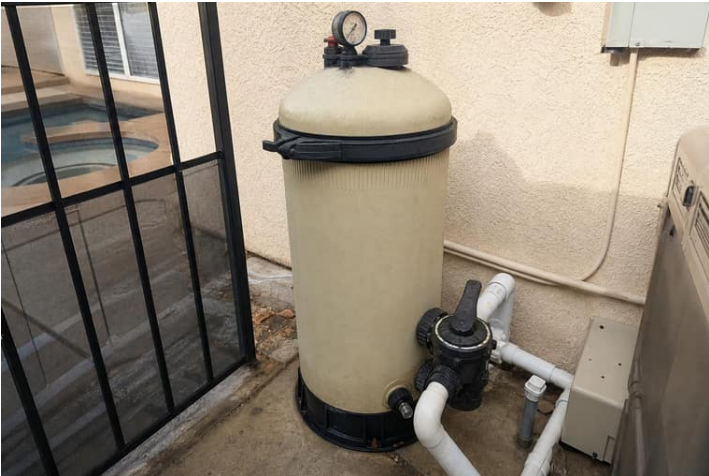
Pump, Filtration, and Plumbing 6.2a - Filter tank, gauge, and visible fittings.

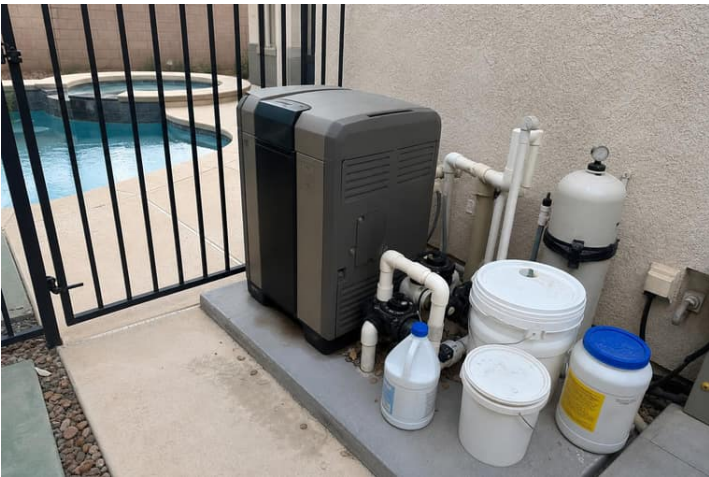
Heater and Heating Equipment 7.1a - Pool heater visible condition and clearance area.

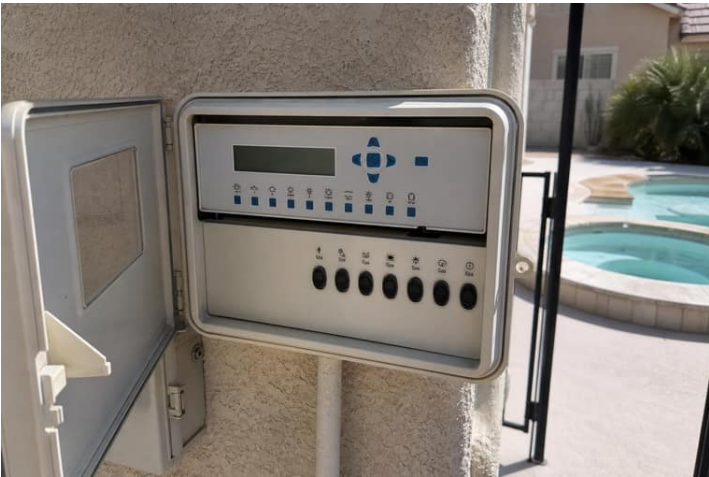
Status: inspected  
Defects: Light did not operate; Control did not operate  
Notes: Spa light did not respond at the automation panel during the check.

Electrical, Lighting, and Bonding 8.3a - Pool control and lighting equipment observed.

Have a licensed electrician or pool technician diagnose and repair the spa light and control circuit.

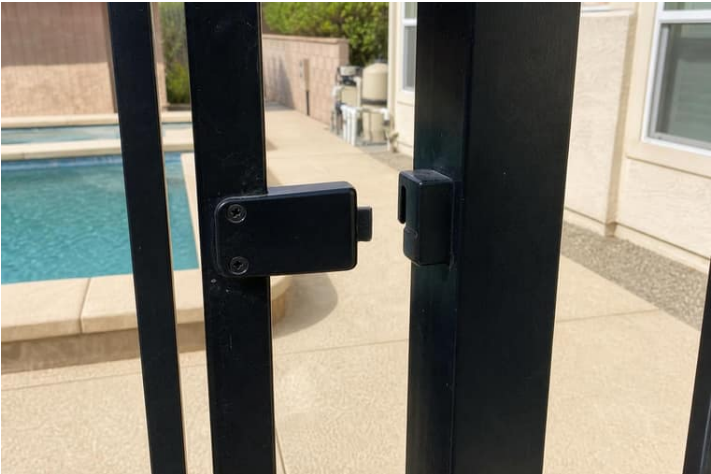
| <div>Gate self-closing/latching</div> <div>Status: inspected</div> <div>Defects: Gate did not self-close; Gate did not latch</div> <div>Notes: West side pool gate did not consistently self-close and latch.</div> | CORRECTION NEEDED |

Safety Barriers and Devices 9.2b - Gate latch alignment gap after the gate failed to self-latch.

Safety Barriers and Devices - The west side pool gate did not consistently self-close and did not reliably latch.  
Have the gate hardware adjusted or repaired to ensure reliable self-closing and self-latching function for safety compliance.

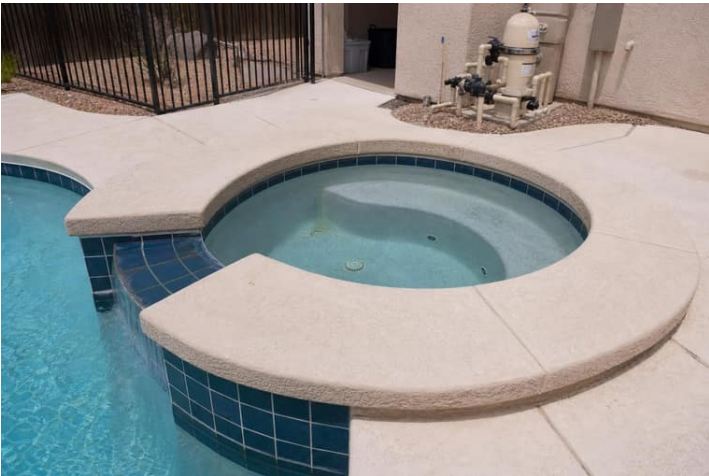
Spa Systems and Limitations 10.1a - Attached spa overview and operating condition.
